Final Report

Maple Creek Integrated Watershed Management Plan

July 2021
KWL File No. 646.046-300

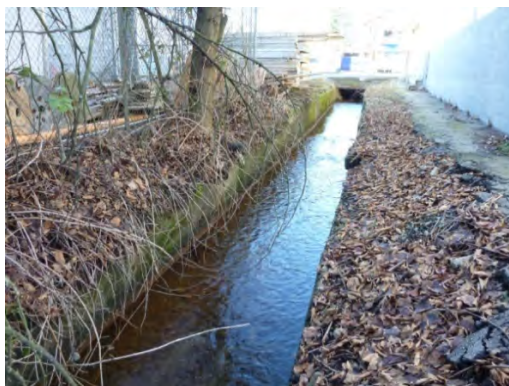
(a) Concrete Flume & buildings downstream of Kingsway

- Historical flooding at Coquitlam Glass on Bedford Street in the lower reaches of Maple Creek, requiring temporary pumping. Bedford Street and several properties are affected by flooding.

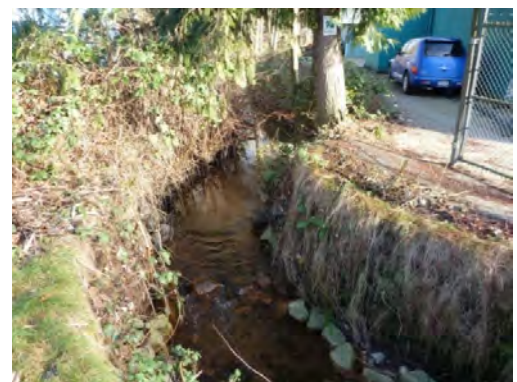
(b) Channel upstream of Bedford

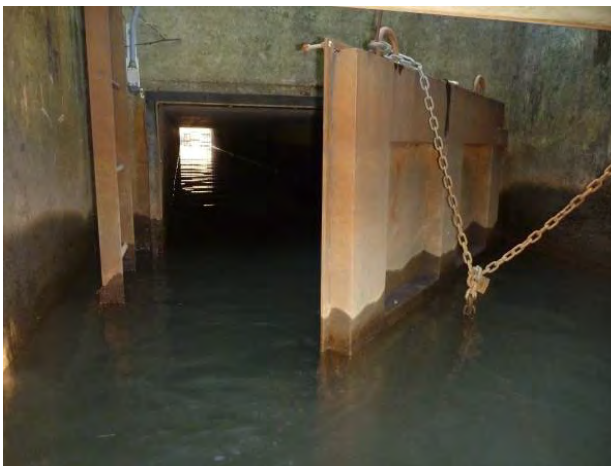
- Coquitlam River dyke flood box flapgate (downstream end) (Photo 2-1a): The floodbox consists of rectangular culvert (1.7 m x 1.7 m) and with a heavy steel, side-mounted flapgate on the outlet end. The flapgate has been previously identified as an impediment to fish passage because of the low frequency with which the gate remains open to fish passage (M. Coulter-Boisvert, pers. comm.). Access was recently improved by adding a weight to the back of the flapgate to increase the time that the flapgate stays open and reduces the size of flows needed to re-open the gate. However, the flapgate may still impede fish passage at certain times during the migration period; and

(a) Dyke Floodbox and Flapgate

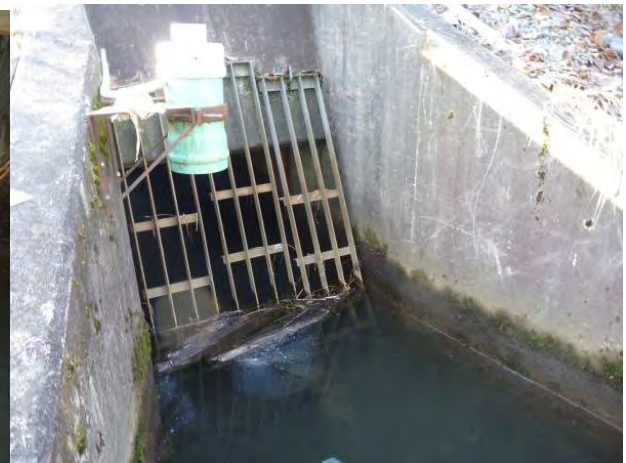
- Coquitlam River dyke floodbox grill (upstream end) (Photo 2-1b): The grill on the upstream end of the floodbox is to capture garbage and debris. It has previously been identified as an impediment to fish passage (Thomson, 1997). The grill was modified slightly to improve fish passage (one bar removed). However, the grill can still become clogged and block fish passage if it is not regularly cleaned. Streamkeepers have suggested that the grill is not necessary and could be removed.

(b) Dyke Culvert Grill (upstream end)

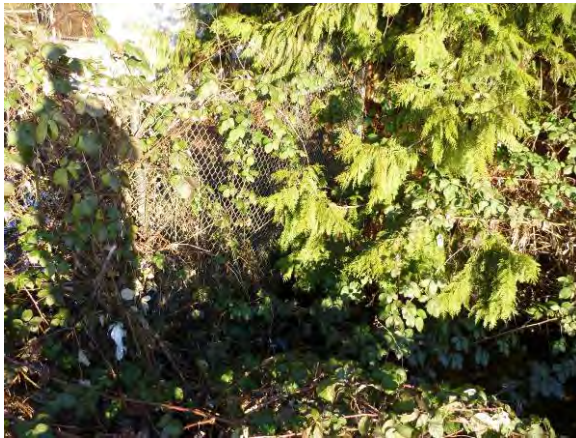
- Instream fence at 2617 Kingsway Avenue (Photo 2-2a): A submerged chain-link fence on private property crosses the creek and can provide a barrier when clogged with wood and debris. The Streamkeepers have attempted to improve fish access at this location by lifting the fence;
- Concrete weir downstream of Lougheed Highway (outlet of Jervis Street Pond) (Photo 2-2b): This two-step concrete weir is located at the outlet to the inline pond at Jervis Street. Because of its height, the weir is a partial barrier to fish passage, especially for Chum Salmon. Also, sediment appears to be accumulating at the base of the weir steps and is filling in the jump pools. In the long-term, this could further restrict fish passage;

(a) Instream Fence at 2617 Kingsway Ave.

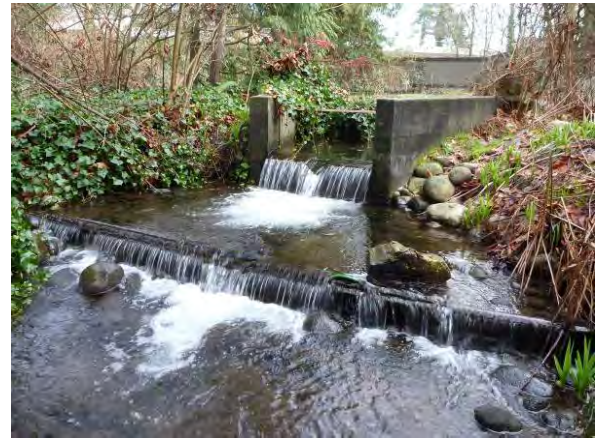
(b) Concrete Weir Downstream of Lougheed Hwy

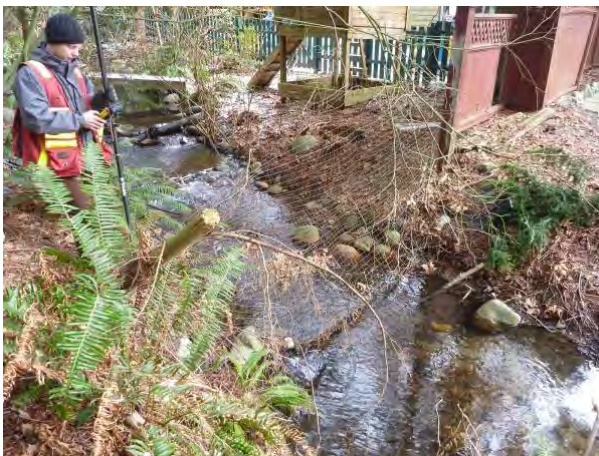
- Instream fences at 3691 McRae Crescent (Photo 2-3a): Similar to the fence mentioned above, two submerged stucco wire fences cross the creek on the north and south property lines at this location. They could provide a barrier to fish passage when clogged with wood and debris; and
- Diversion at south end of Ozada Avenue (Photo2-3b): The diversion wall previously had a side-mounted flapgate on the upstream side of the opening. This flapgate was a barrier to fish passage and has since been removed. However, the opening conveying flow to Maple Creek is only 30 cm in diameter and could easily be blocked (either intentionally or otherwise) which would block fish passage but could dry out Maple Creek downstream.

(a) Instream fences at 3691 McRae Crescent

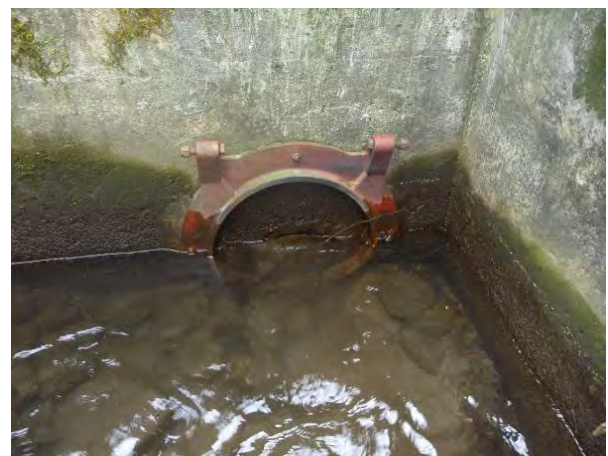
(b) Diversion at South End of Ozada Ave.

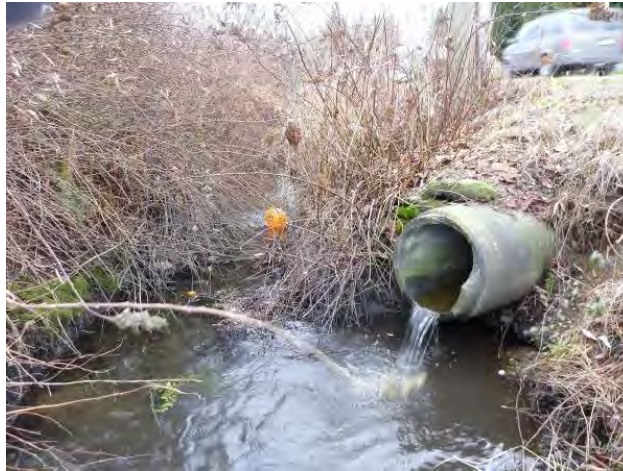
- Davies Avenue/Fox Street culvert on Fox Creek (Photo 2-4): The 120 m long culvert which conveys flows from Fox Park to the ditch along Davies is not passable to fish and the outlet is raised 20 to 30 cm above the water surface in the ditch. Maple Creek Streamkeepers have proposed daylighting this part of Fox Creek to improve fish access;

Davies Ave./Fox St. Culvert on Fox Creek

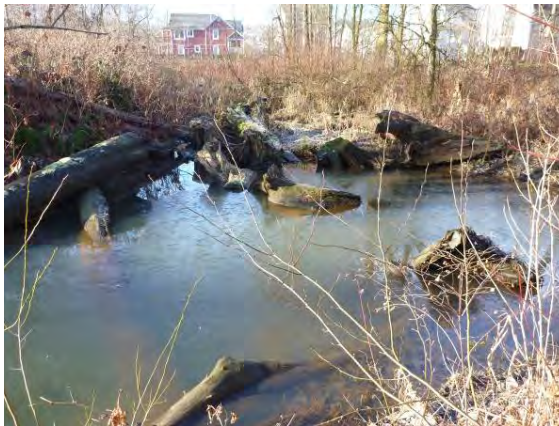
(a) Lowermost Bedford Habitat Pond

- Bedford Habitat Ponds (Photo 2-5a): Two off-channel ponds were created between the dyke and Chine Drive (at the foot of Bedford Street) to provide rearing habitat, primarily for Coho Salmon. Both ponds contain large woody debris (logs, root wads) placed to provide additional cover for rearing fish;
- CPR Triangle Habitat Pond (Photo 2-5b): This inline pond was expanded in 1996 to provide rearing habitat, primarily for Coho Salmon;

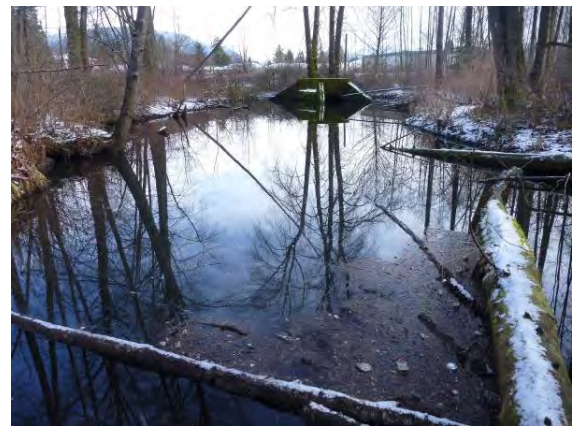
(b) CPR Triangle Habitat Pond

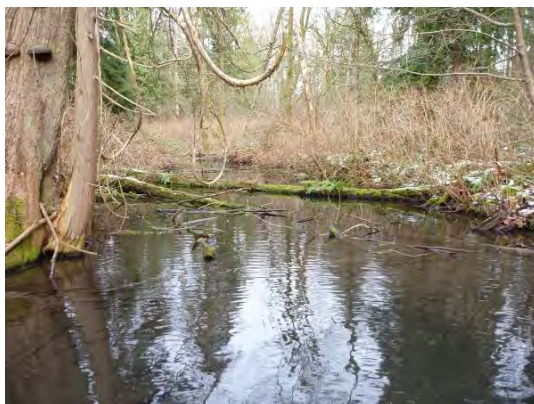
- Ozada Habitat Pond (Photo 2-6a): This off-channel pond was created to provide additional rearing habitat capacity in the upper reaches of the watershed. The pond is the site of annual juvenile Coho Salmon releases;

(a) Ozada Habitat Pond

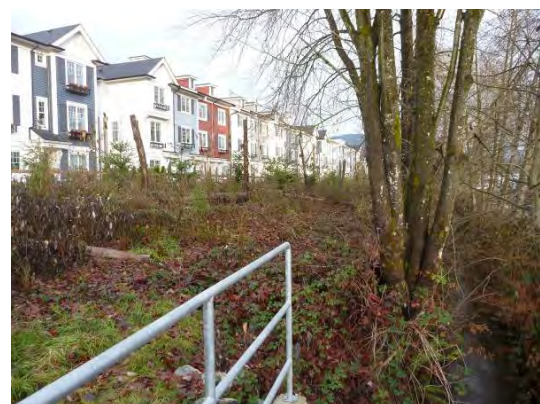
- Spawning Gravel Placements: Spawning gravels have been placed instream at several locations in the watershed to improve spawning habitat; and
- Riparian Plantings: Native trees and shrubs have been planted in locations throughout the watershed to restore or enhance riparian vegetation. For example, a 15 m riparian buffer was recently reestablished along one side of Maple Creek west of Bedford Street as part of the adjacent townhouse development (Photo 2-6b). Other plantings have been conducted by Maple Creek Streamkeepers to improve existing riparian vegetation.

(b) Riparian Restoration West of Bedford St.

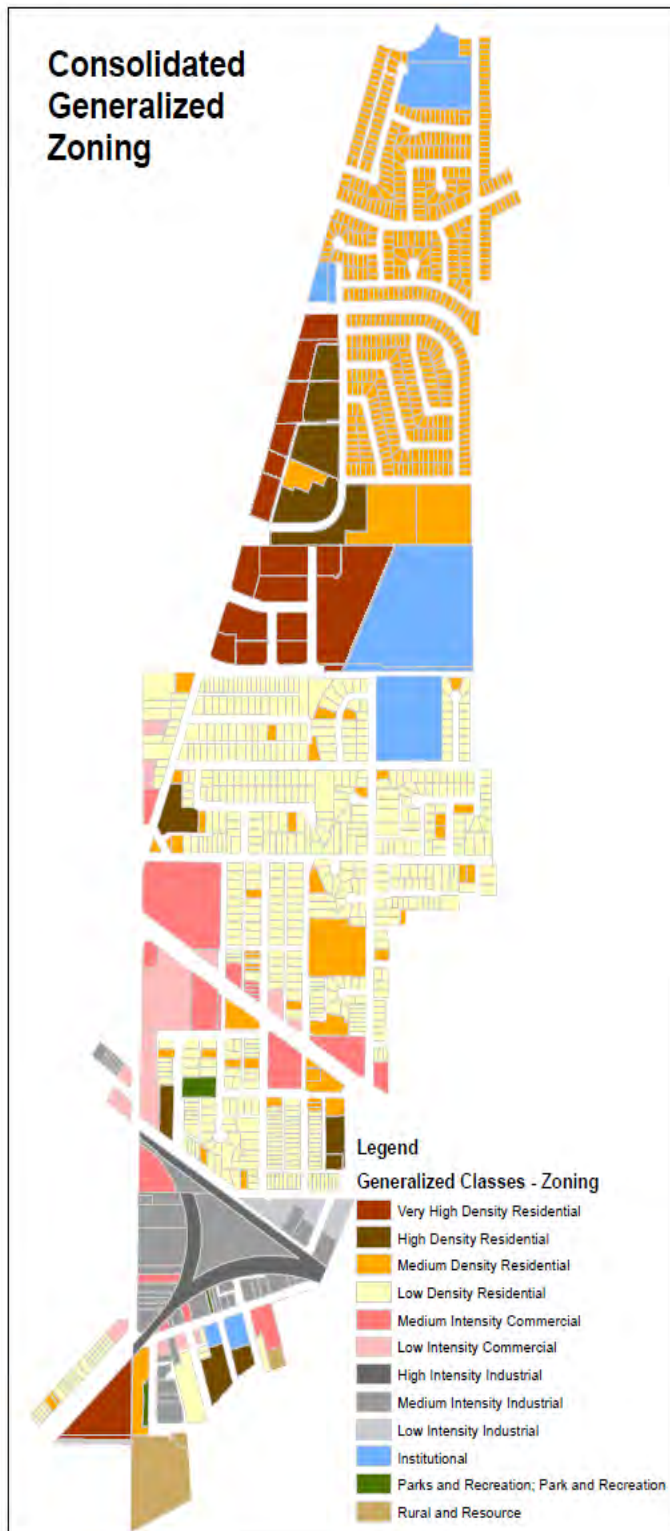
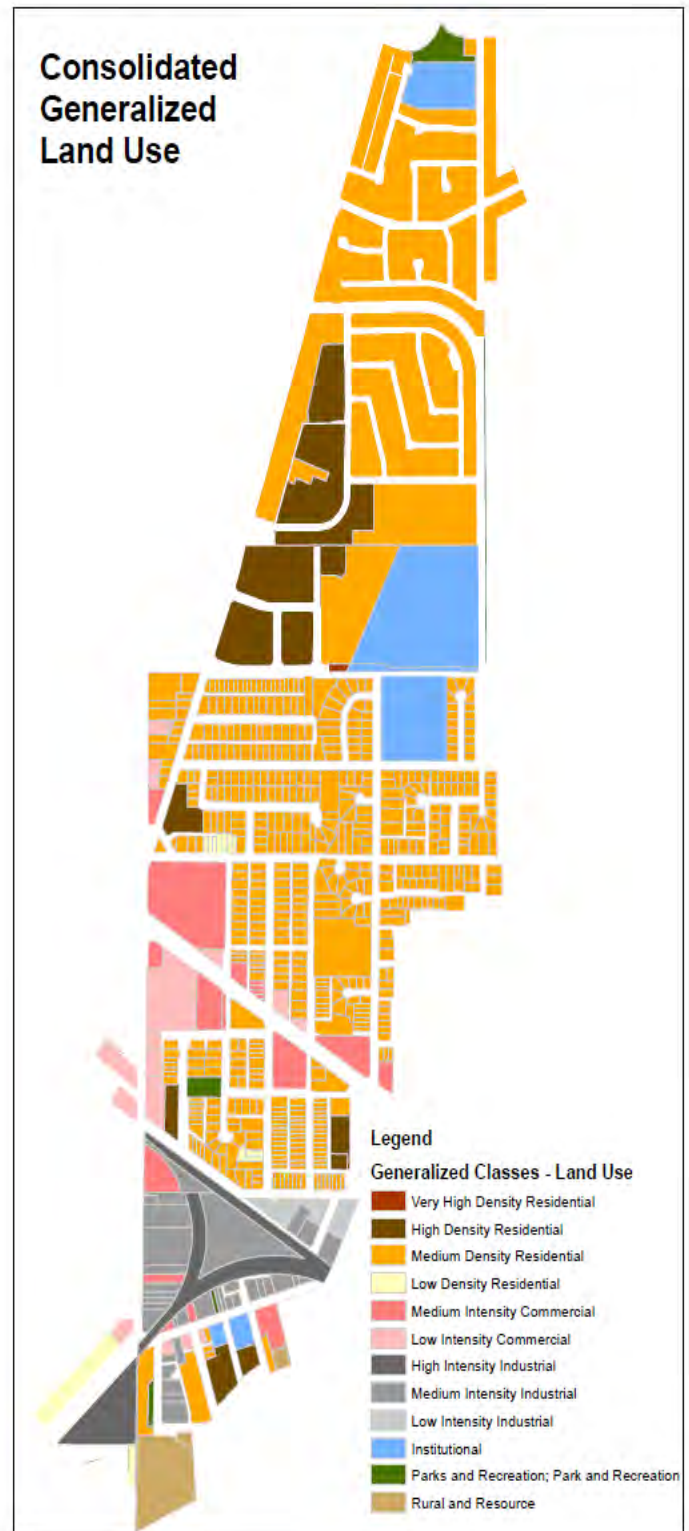
Soils Map

An assessment of hydrogeological conditions was conducted by the study team. A map of the surficial geology of study area is included as Figure 2-4. In general:

The groundwater portion of XP-SWMM – RUNOFF was used to estimate the groundwater and interflow portions of the runoff hydrograph. Figure 2-4 shows the surficial geology that was used to determine soil parameters. The majority of the watershed is gravel and sand soils, with some till in the areas South of Kingsway.

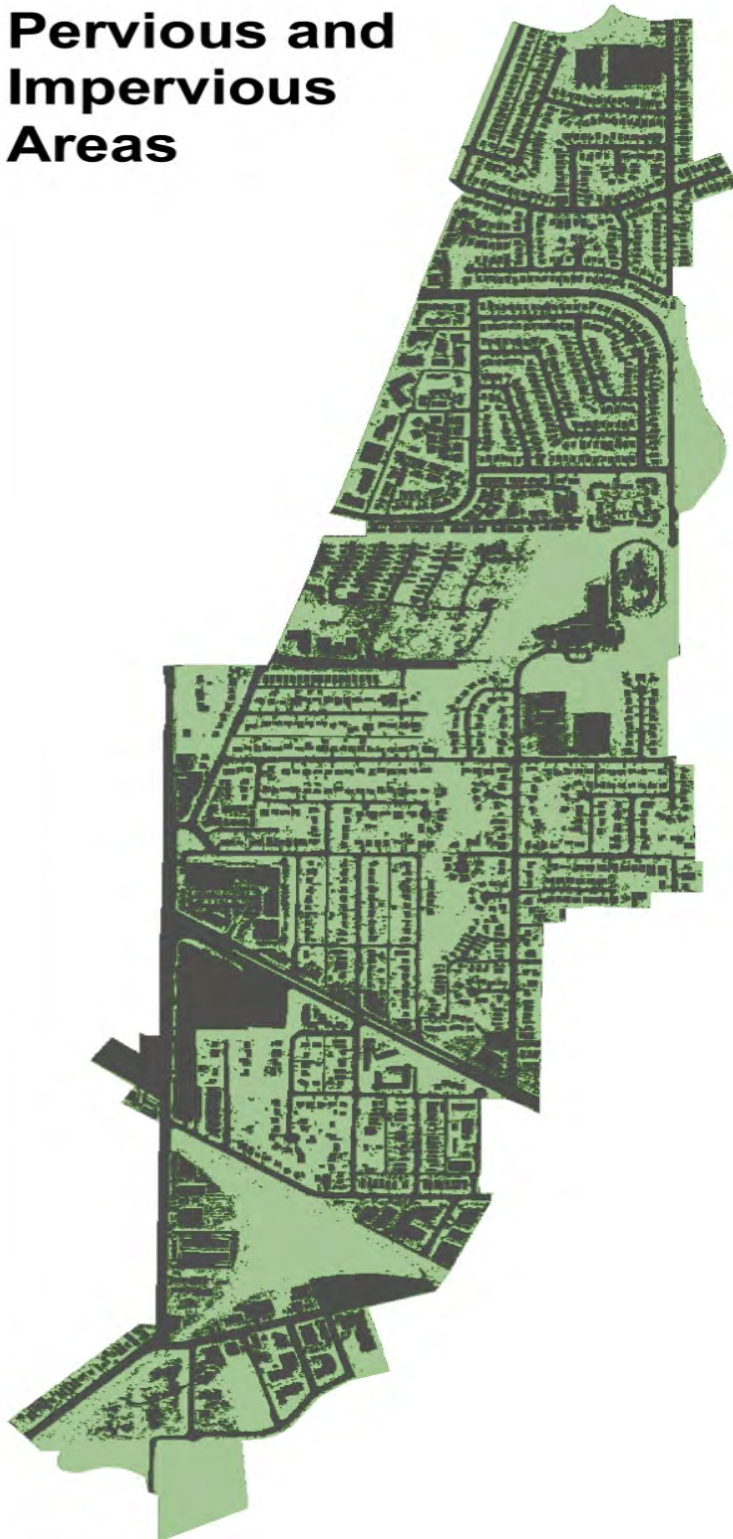
**Figure 2-6: Existing Pervious and
Impervious Areas from 2010 Ortho photography**

TIA percentages were estimated by spectral analysis of ortho-photographs to identify pervious/impervious areas for each parcel. See Figure 2-6.

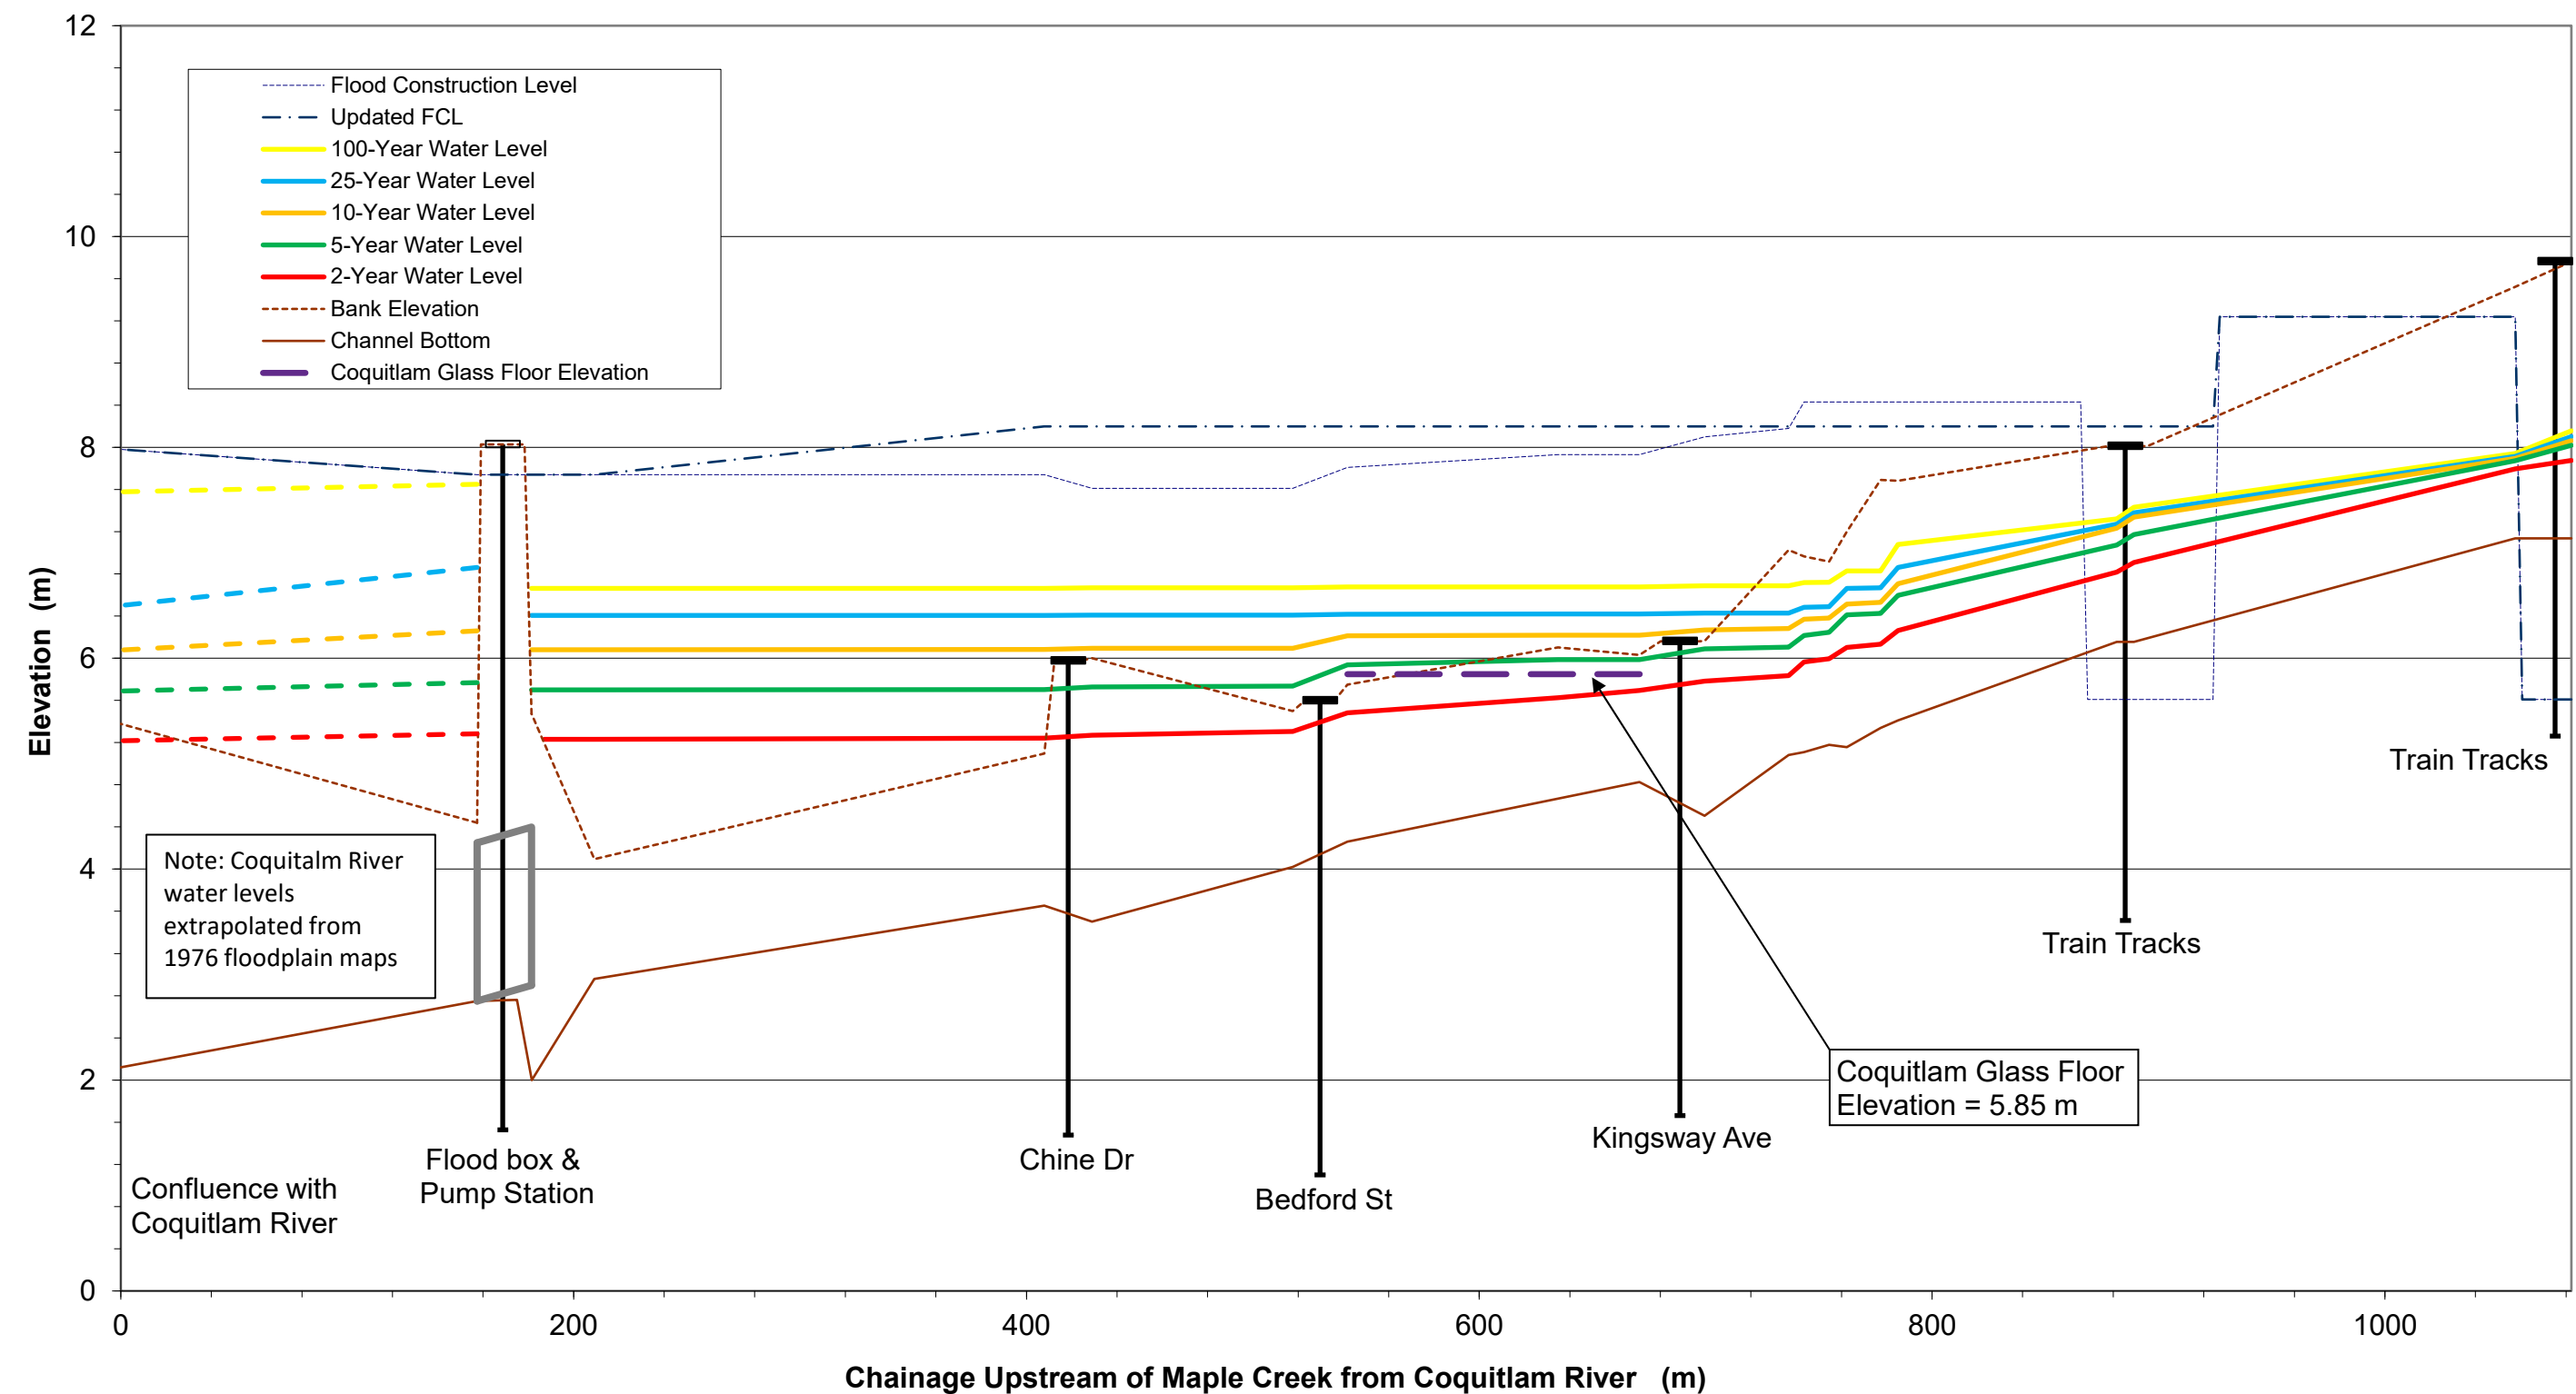
Maple Creek Water Level Profiles: Existing Land Use - Flood Box Closed

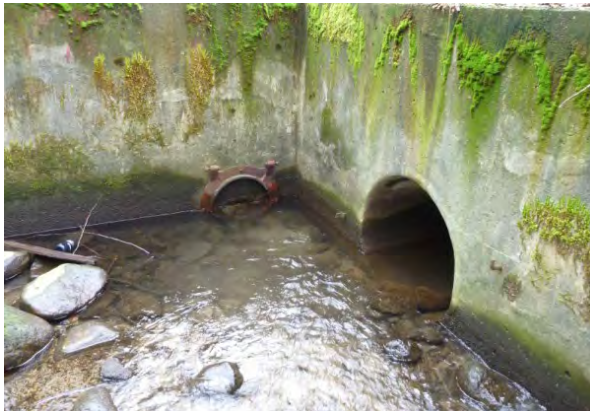
The existing Ozada High Flow Diversion consists of a concrete headwall with a 300 mm concrete pipe on Maple Creek, with high flows diverted to a channel to the east toward Grist Channel and discharges directly to the Coquitlam River.

(a) 300 mm pipe to Maple is on left, 900 mm outfall from stormceptor & residential area on right.

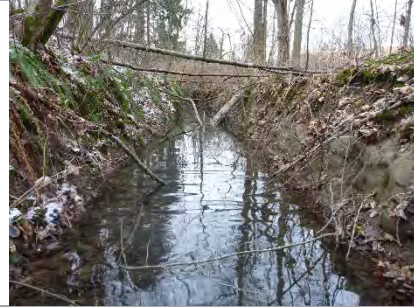
E-1: Low severity site d/s of pump station

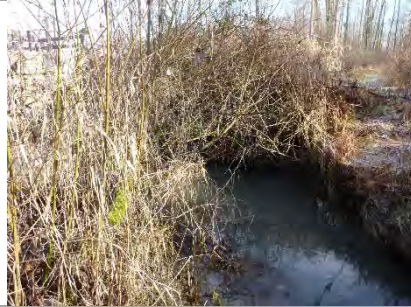
E-2: Low severity site d/s of Chine Dr

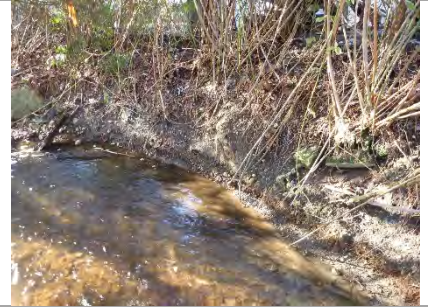
E-3: Low severity site d/s of Kingsway Ave

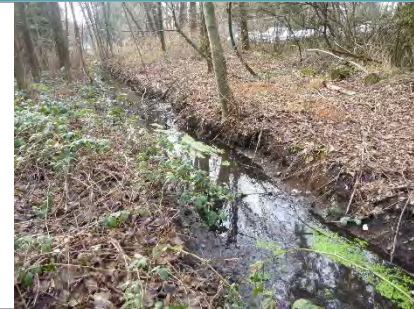
E-4: Low severity site Fox Creek

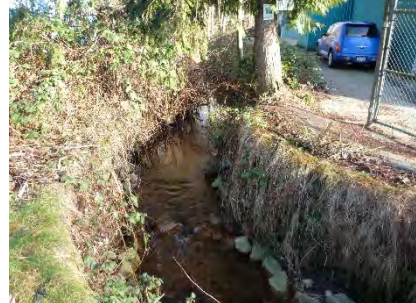
Confined channel at Coquitlam Glass, u/s of Bedford culvert

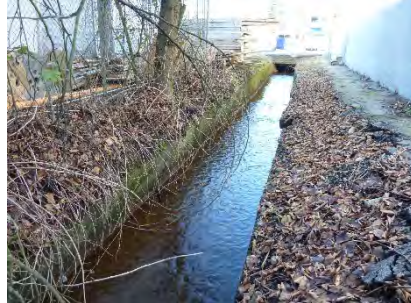
Confined channel, Concrete flume at Kingsway culvert outlet

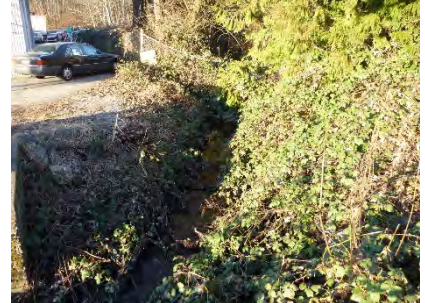
Confined / overgrown channel, d/s of Railway Triangle

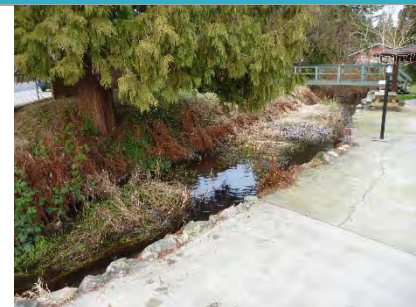
Confined channel, u/s of Davies culvert

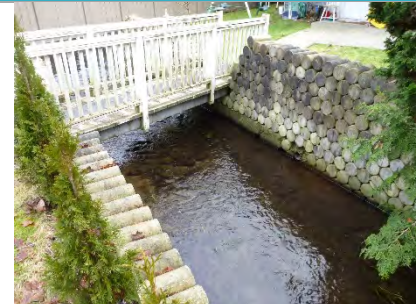
Confined Channel between Raleigh and Gordon

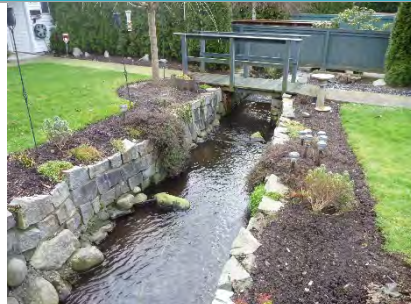
Confined Channel between Raleigh and Gordon

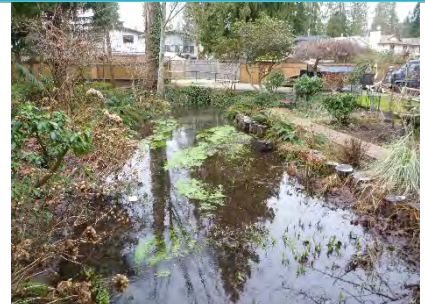
Encroachment u/s Shaftsbury PI

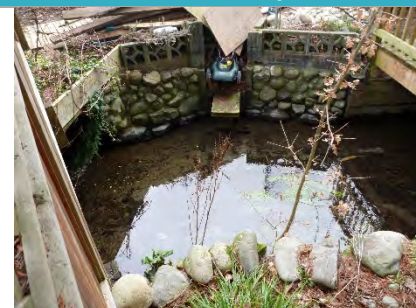
Encroachment u/s Shaftsbury PI

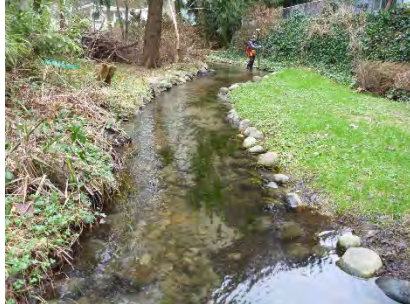
Encroachment near Gail Ave

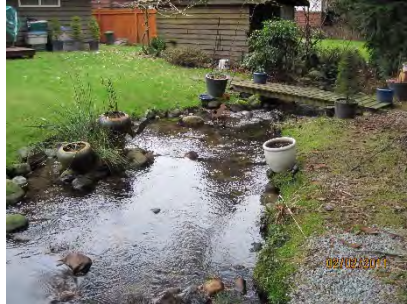
Encroachment d/s of Kitchener Ave

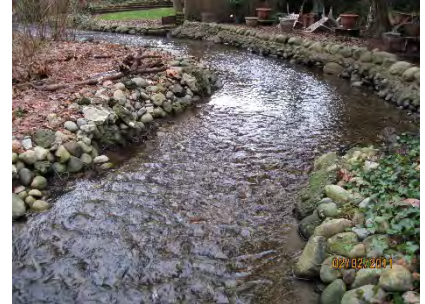
Encroachment u/s Kitchener Ave

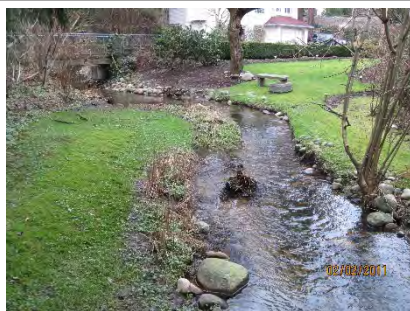
Encroachment at Kitchener Ave

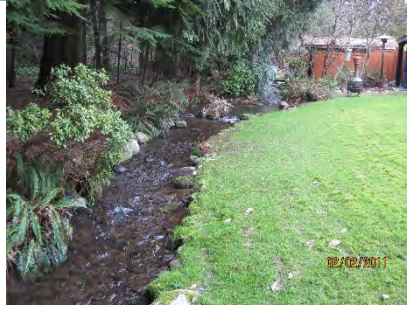
Encroachment u/s Kitchener Ave

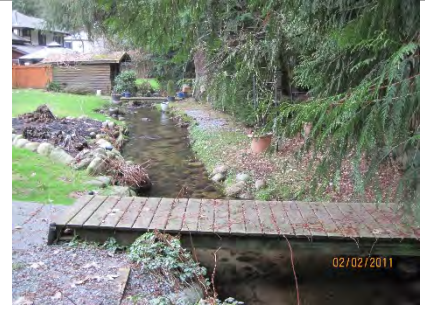
Encroachment u/s Kitchener Ave

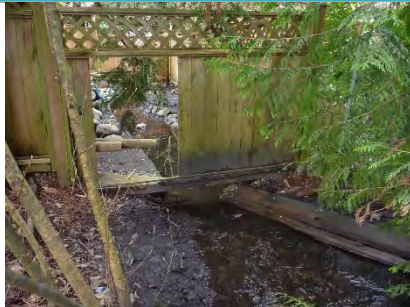
Encroachment on Fox Creek u/s of Fox Park

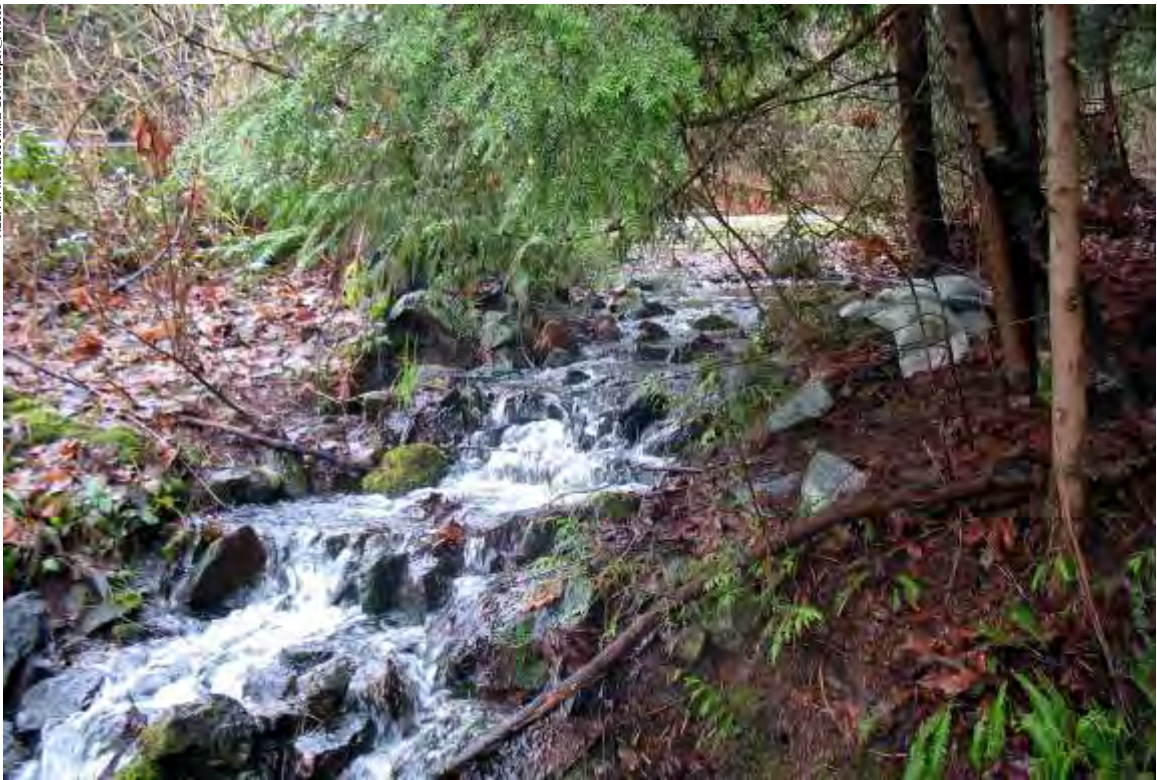
Photo 1.
Groundwater discharge from Maple Creek well sump into Creek.

The Creek begins at a stormwater pipe at the top of Ozada Avenue and flows are augmented at a well sump located approximately 100m downstream (Maple Creek well, Photo 1). Near the foot of Ozada Avenue, the Creek intercepts a high flow diversion structure that relays excess creek flow and City of Coquitlam stormwater to the Coquitlam River during peak runoff periods. The remainder of the flow enters a 300mm diameter pipe at a headwall and continues southwest alongside the grounds of Maple Creek Middle School. Below Lincoln Avenue, the Creek follows a narrow riparian zone through predominantly residential neighbourhoods to Davies Avenue. At this point, it creek crosses the Railway triangle, which has been designated an ecological restoration zone. From Kingsway Avenue southward, it crosses a commercial / industrial lands and a natural area before its confluence with the Coquitlam River.

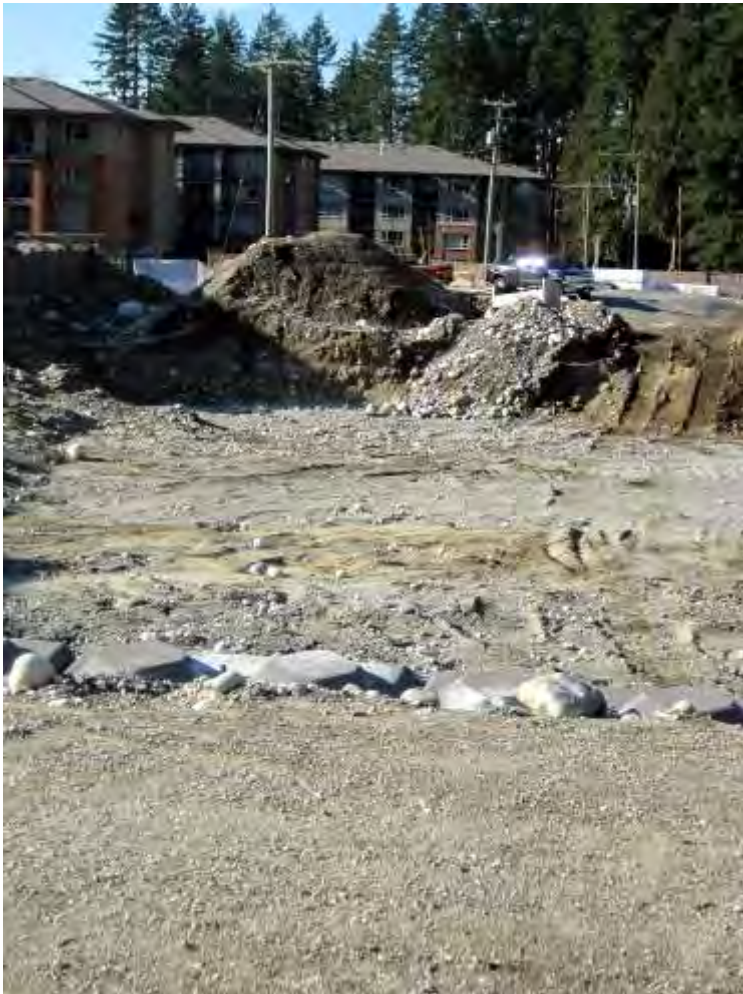
Photo 2.
Exposed sands and gravels in construction excavation at Lincoln Ave. and Pipeline Rd.

As indicated on Fig. 2, the Study Area is predominantly underlain by Pleistocene-aged sand and gravel sediments deposited by pro-glacial streams. Referred to as the Capilano Sediments (Cc), they range in texture from medium sand to cobble gravel, are up to 15m thick, and are commonly underlain by silt to silty clay loam. These sands and gravels are exposed at a large excavation at Pipeline Road and Lincoln Avenue (Photo 2).

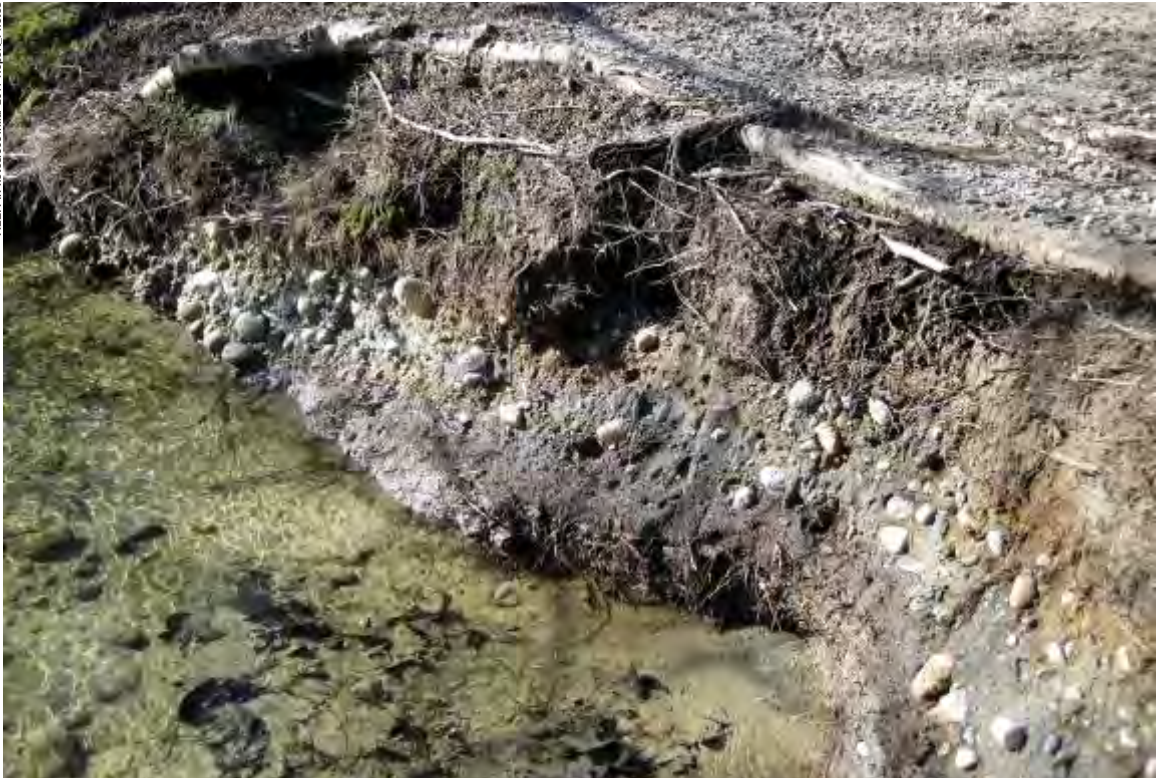
Photo 3.
Coquitlam River bank section near Riverbend Dr.

The southern tip of the Study Area sits atop younger, post-glacial mountain stream channel fill deposits (Saj) and mountain stream deltaic deposits (Sai). The former comprise medium to coarse gravel and minor sand up to 8m thick, and the latter comprise medium to coarse gravel with minor sand up to 15m thick (Photo 3). The Salish deposits are bounded to the south by finer-grained Fraser River Sediments that are normally up to 2m thick. These are described as overbank silty to silt clay loam deposits overlying sandy to silt loam.

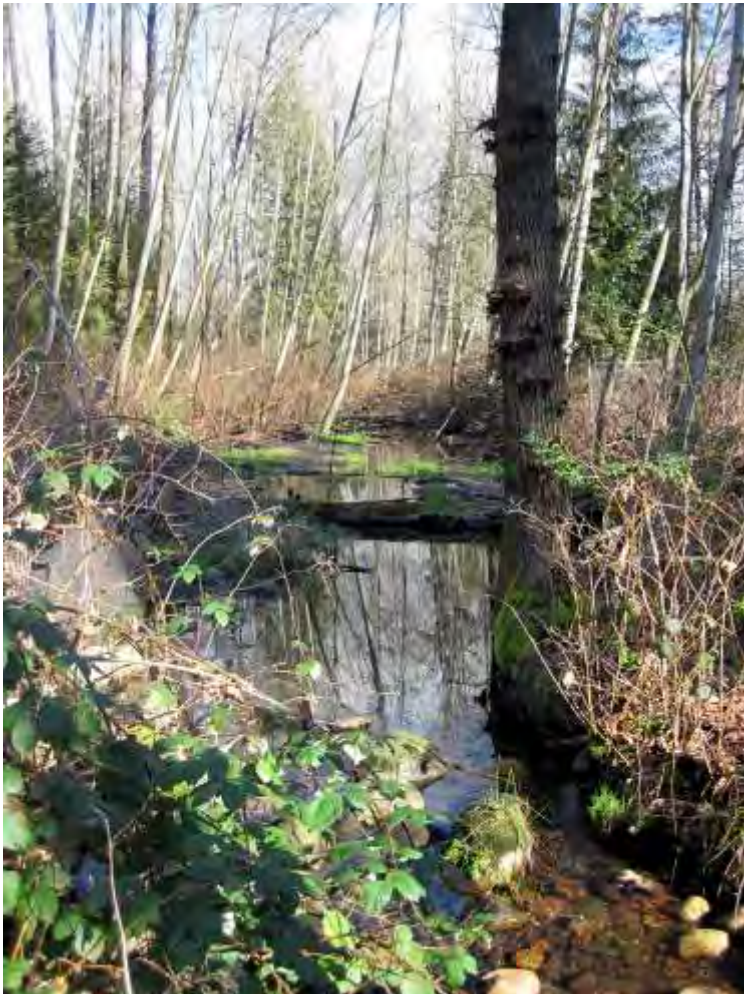
Photo 4.
Ravined section of Maple Creek at
eastern end of Patricia Ave.,
February 10, 2011.

- A flowing spring observed between the Hastings Place and Tuohey cul-de-sacs downstream of Kitchener Avenue. This spring was identified during Piteau's March 8, 2011 site visit. Groundwater seepage into Maple Creek (the Creek) is also likely occurring along the ravined section at the eastern end of Lincoln Avenue (Photo 4).

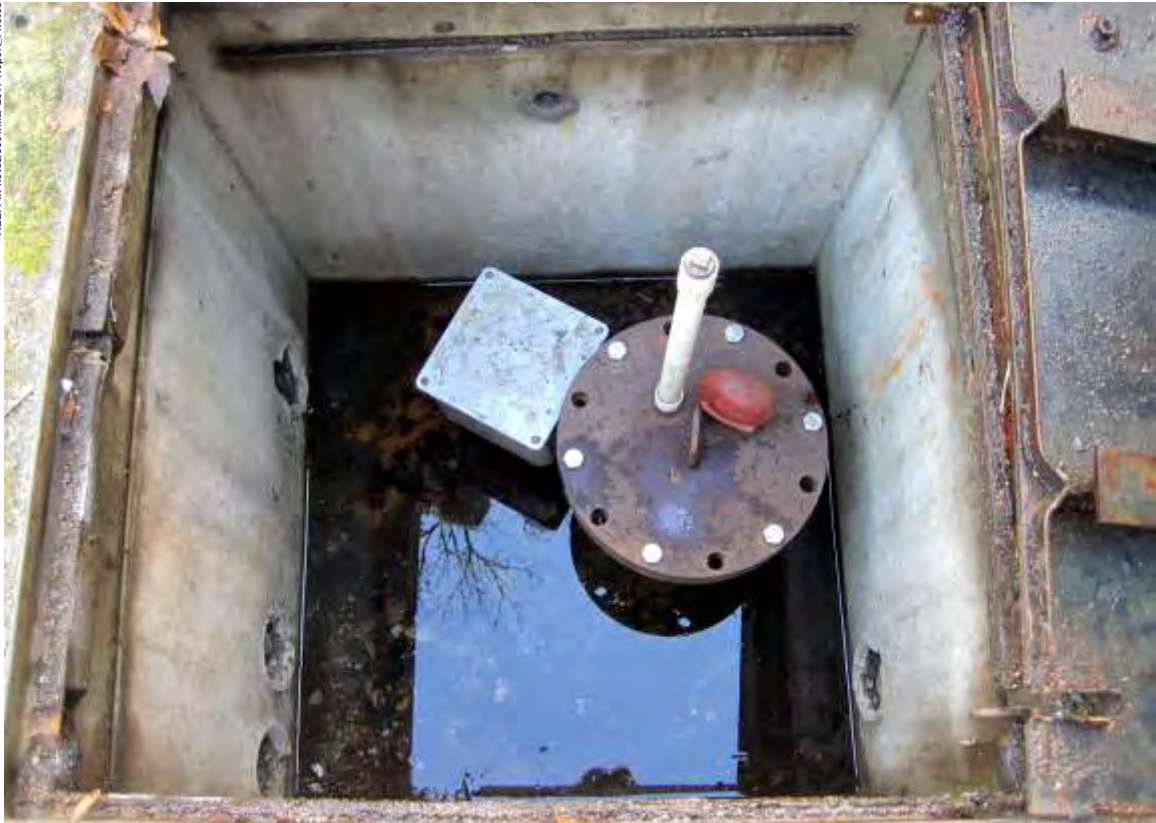
Photo 5.
Surface completion of Maple Creek well.

In September 1996, the Maple Creek production well was drilled near Salt Spring Avenue and Gabriola Drive as part of the Maple Creek Habitat Improvement Project (Piteau, 1996). This well, also referred to as the Maple Creek "Wet Well" or "PW96-1," was intended to augment summer baseflows in Maple Creek and Grist Channel at a targeted flow rate of 28 L/s (400 USgpm). A photo of the wellhead is provided as Photo 5.

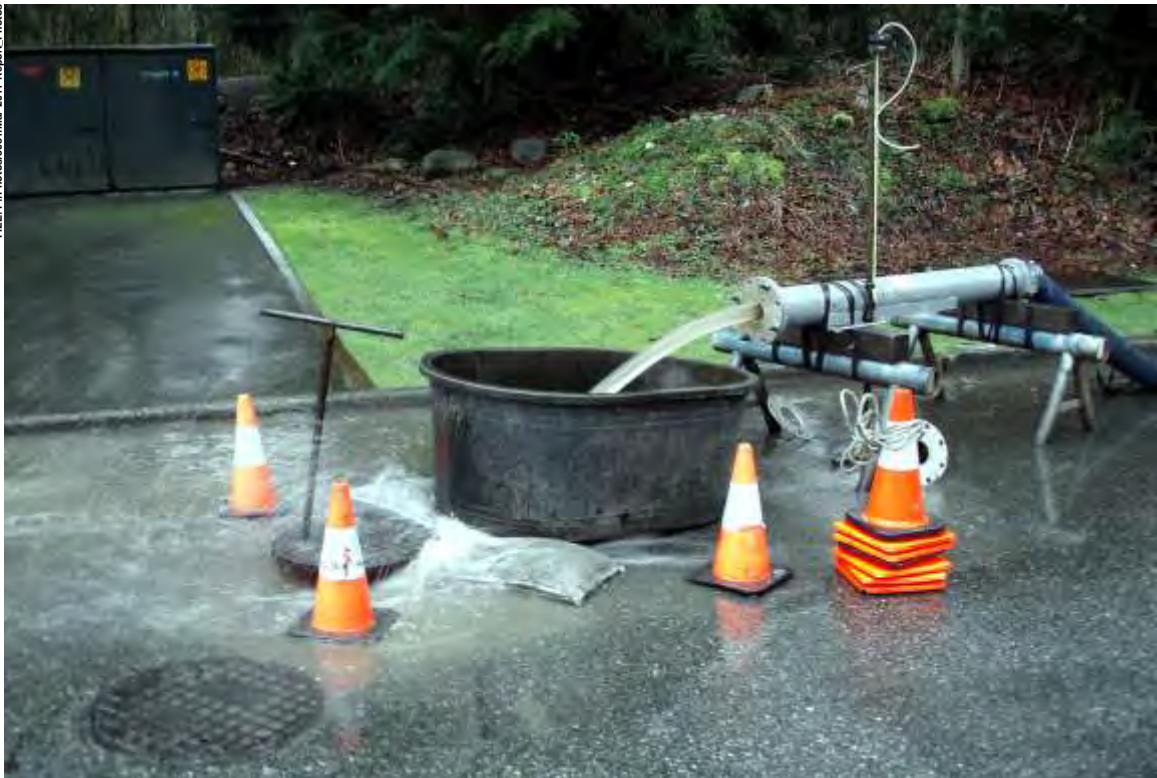
Photo 6.
Damaged pump pulled from Maple Creek well in September 2010.

- The well has experienced a 75% loss in well efficiency since it was first commissioned in 1996. Its current sustainable yield is approximately 16.4 L/s (261 USgpm). The well was originally rated to produce 44.2 L/s (700 USgpm);
- The likely cause of loss of performance is accumulation of biomass and packing of fine sediment in and around the well screen;
- Historical wear on the pump may have been caused by over-sizing of the pump (too little annular space) and repeat start-stops due to low pumping water levels; and
- The quality of water produced by the well continues to be suitable for discharge to Maple Creek.

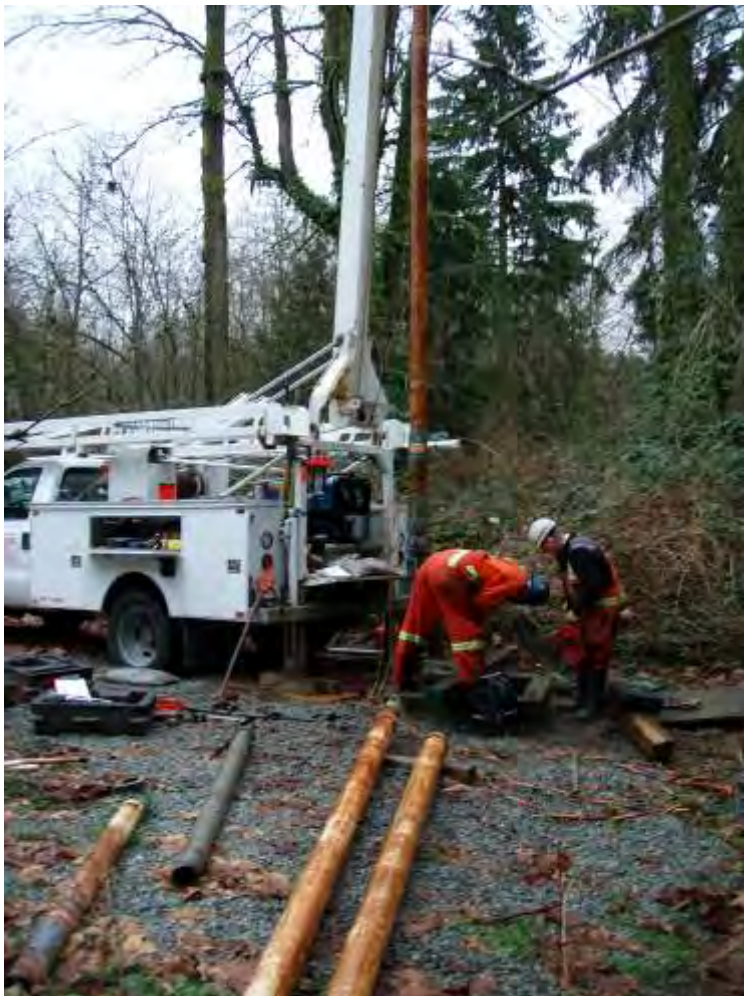
Photo 8.
Pump and drop pipe pulled from Maple Creek well Feb. 16, 2011.

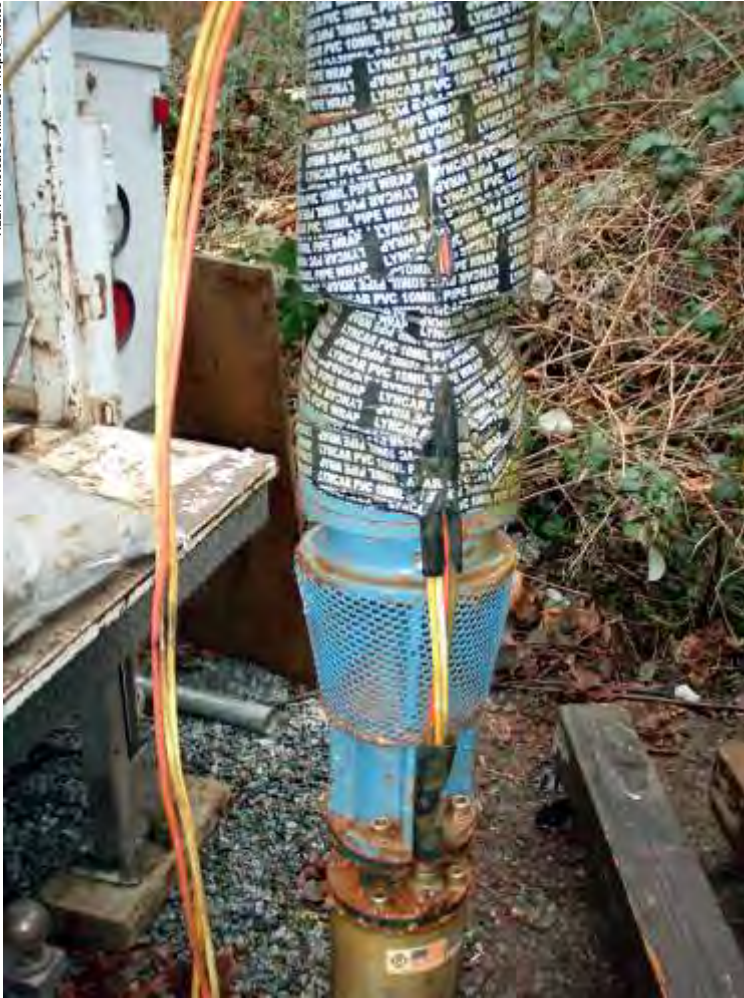
Photo 9.

Close-up of Maple Creek Well Pump bowls, intake, and motor, Feb. 16, 2011.
