Final Report

Maple Creek Integrated Watershed Management Plan

July 2021
KWL File No. 646.046-300

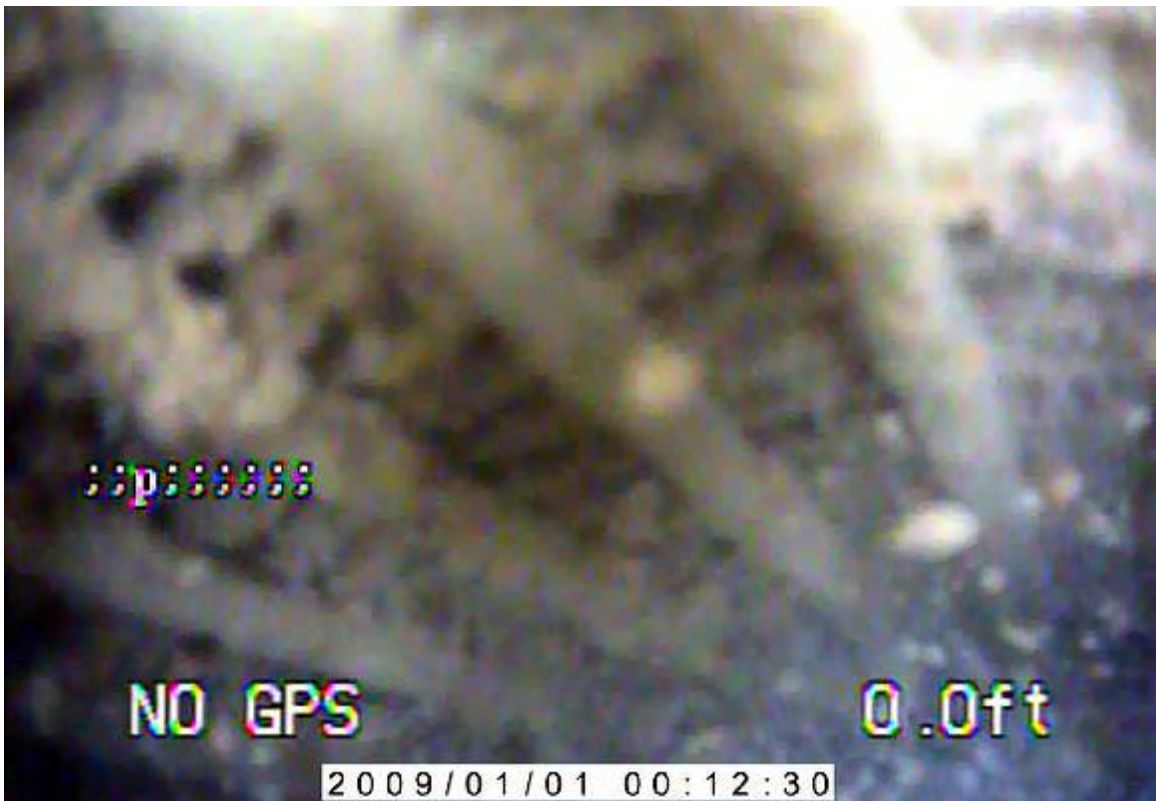
Photo 10.

Snapshot of partially-obstructed slot openings in upper 1.5m of well screen during camera inspection February 15, 2011.

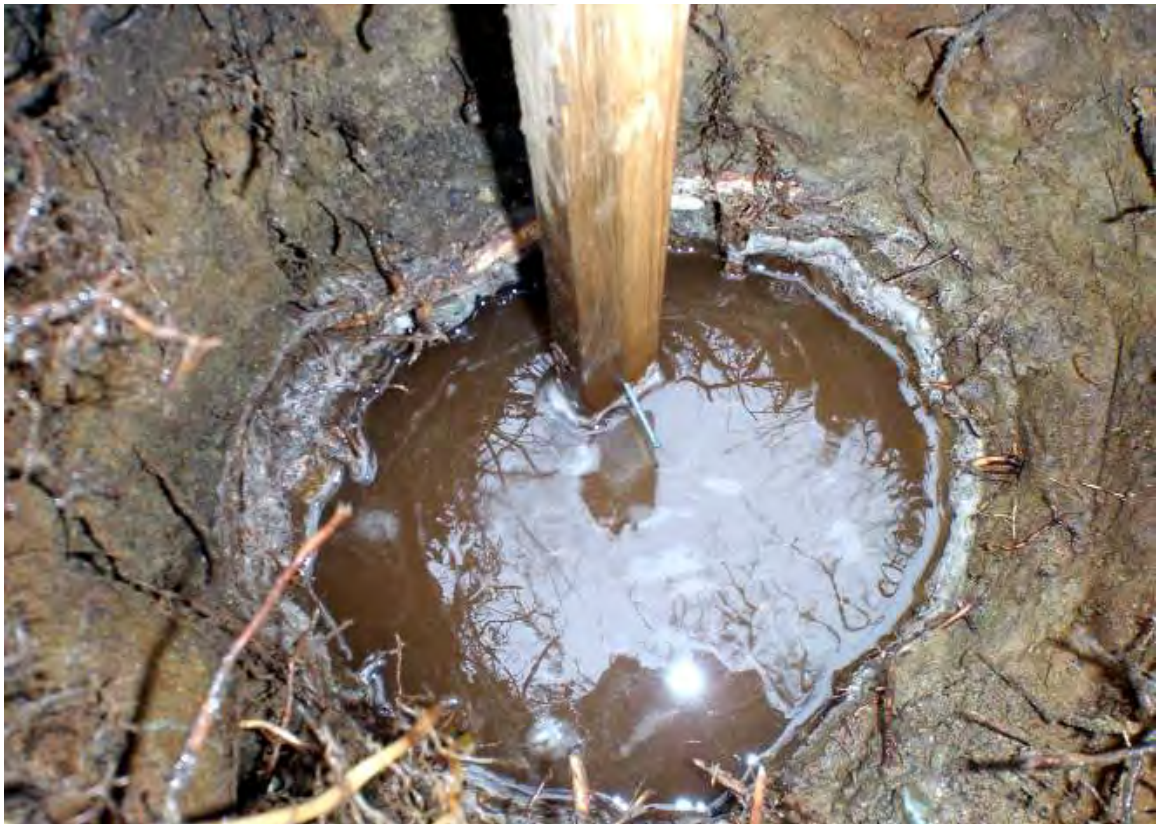
Photo 12.
Percolation test at foot of Ozada Ave., near school.

Percolation tests were conducted on March 8, 2011 in accordance with the methodology described in the BC Ministry of Health Sewerage System Regulation⁸. Each test involved excavating a two-foot deep, one-foot square test hole and filling it with water twice (Photo 12). After this pre-soak step, the hole was refilled to six inches from the bottom multiple times and the time for the water level to drop one inch was recorded. The test was concluded after consecutive trials did not vary by more than two minutes per inch. The final (slowest) percolation time was taken to be the most representative value of the suite.

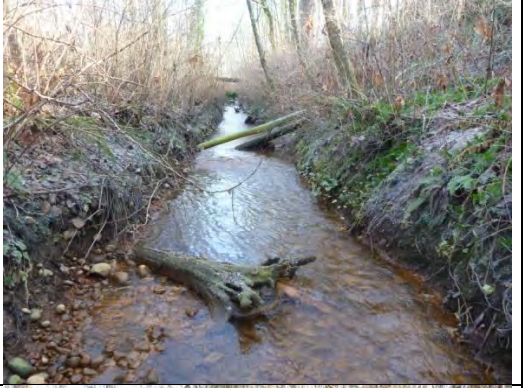
Reach	Stream Class	Description	Photo
Maple R1 Confluence with Coquitlam River upstream to dyke flapgate	Permanent Fish-bearing	<p>Straight channel with steep banks. Substrates a mix of cobbles and gravels (and some riprap downstream of floodbox) but overlain with fine sediment and organic debris in many areas. Gravels heavily embedded and largely unsuitable for spawning. Riparian vegetation relatively intact. Large woody debris placed throughout reach (fixed by rebar) provides good instream cover for rearing juvenile salmonids.</p> <p>Habitat Quality: Spawning – Low; Rearing – Moderate Riparian Forest Integrity (RFI) = 78.6%</p>

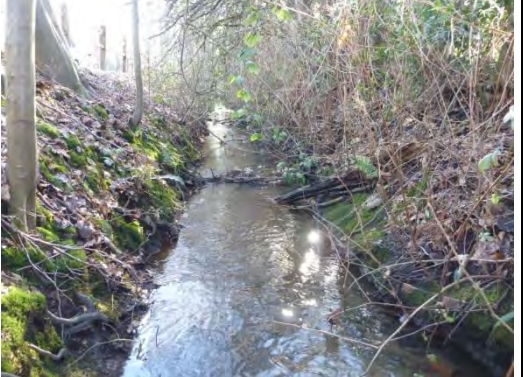
Maple R3 Chine Dr upstream to Bedford St	Permanent Fish-bearing	<p>Channelized section with steep banks and severe encroachment on left bank from road and sidewalk (Bedford St). Lack of channel complexity and instream cover although overhanging vegetation provides some cover. A 15 m wide riparian buffer on right bank was recently planted as part of adjacent townhouse development. Both Chine Dr and Bedford St culverts are open-bottomed.</p> <p>Habitat Quality: Spawning – Low; Rearing – Low RFI = 15.7%</p>

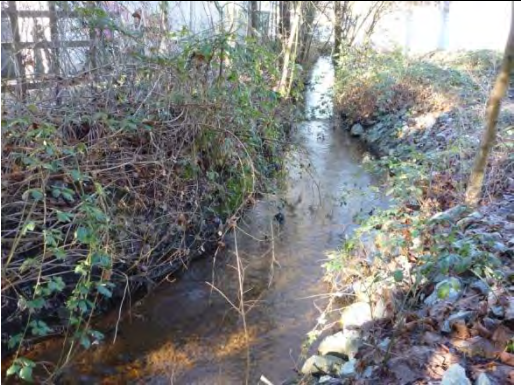
Reach	Stream Class	Description	Photo
Maple R4 Bedford St upstream to CPR rail line north of Kingsway Ave	Permanent Fish-bearing	<p>Heavily encroached and modified section with some eroding bank areas. Industrial/commercial development within few meters of creek. Small sections of gravel at City-owned lane right-of-way and upstream of Kingsway Ave known to be used by spawning salmon (likely Chum). Confined to 50 m concrete flume downstream of Kingsway Ave. Several driveway crossings upstream of and along Kingsway Ave. Minimal natural instream cover. Riparian corridor less than meter wide throughout and mostly non-native Himalayan blackberry and Japanese knotweed.</p> <p>Habitat Quality: Spawning – Moderate; Rearing – Low RFI = 17.9%</p>

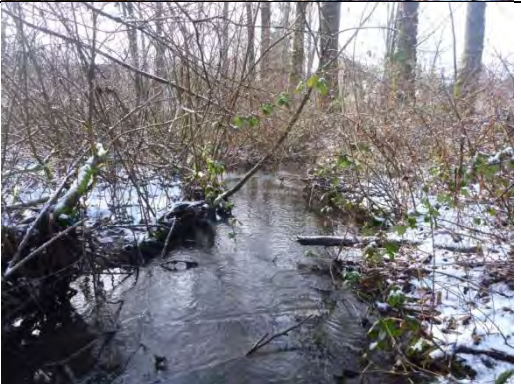
Maple R5 “CPR Triangle”	Permanent Fish-bearing	<p>Natural, meandering section through large habitat protection area. Substrates dominated by fine sediment with few cobble/gravel deposits. Large inline pond at upstream end (downstream of Davies Ave) but lacks instream cover except at downstream end. Naturally occurring large woody debris provides good cover in stream section. Evidence of past beaver dams at pond outlet. Opportunities for enhancement.</p> <p>Habitat Quality: Spawning – Low; Rearing – Moderate RFI = 88.1%</p>

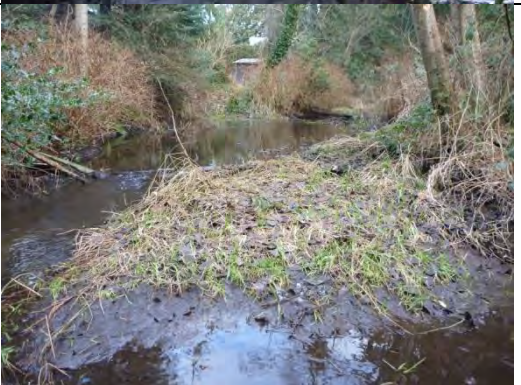
Maple R6 Davies Ave upstream to 40 m downstream of Raleigh Ave	Permanent Fish-bearing	<p>Wide, slow-moving section with mostly fine substrates in several deposition areas. Reed canarygrass abundant in shallow instream areas within channel. Residential yards encroach on both banks. Several retaining walls right at stream bank. Fine sediments common throughout and few areas of exposed spawning gravels. Evidence of bioengineering (willow fences) to stabilize left bank in middle section of reach. Reed canarygrass abundant in shallow instream areas within channel. Invasive plants dominate vegetation on both banks (English ivy, yellow lamium, periwinkle, Japanese knotweed).</p> <p>Habitat Quality: Spawning – Low; Rearing – Low RFI = 21.6%</p>

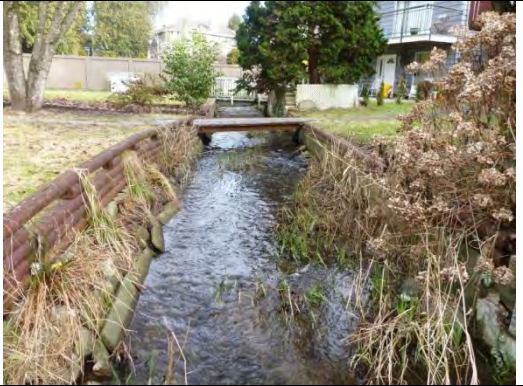
Reach	Stream Class	Description	Photo
Maple R7 40 m downstream of Raleigh Ave upstream to Gordon Ave	Permanent Fish-bearing	<p>Heavily encroached and channelized section. Retaining walls and lawns at stream edge on both banks virtually throughout. Cobble/gravel substrates abundant but covered by fine sediment in many areas and becoming embedded. Some small areas becoming choked with reed canarygrass. No natural instream cover. Little or no riparian vegetation.</p> <p>Habitat Quality: Spawning – Moderate; Rearing – Low RFI = 8.7%</p>

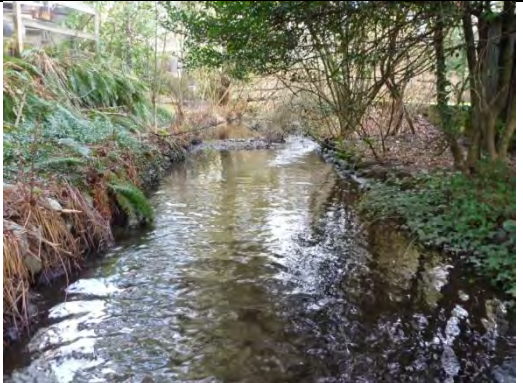
Maple R8 Gordon Ave upstream to Lougheed Highway	Permanent Fish-bearing	<p>Semi-natural section through townhouse complex. Yards and patios right near stream edge. Small pocket with cobble/gravel substrates suitable for spawning. One small (downstream end) and one larger (upstream end) inline pond. Two-step concrete weir at outlet of larger pond (partial barrier to fish passage). Ponds have little cover for rearing fish. Riparian corridor narrow but more tree and shrub cover compared to reach below and mostly native species (western redcedar, salmonberry).</p> <p>Habitat Quality: Spawning – Moderate; Rearing – Moderate RFI = 35.2%</p>

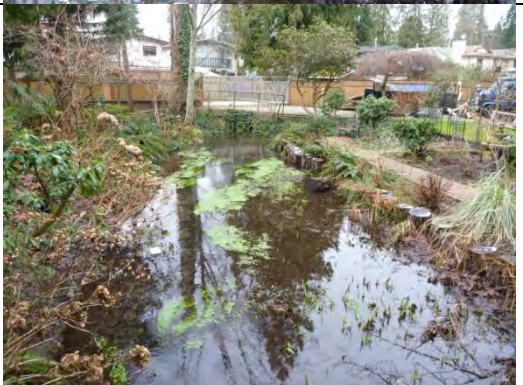
Maple R9 Lougheed Highway upstream to 3346 Jervis St	Permanent Fish-bearing	<p>Wide, slow-moving section dominated by fine substrates. Little to no suitable spawning gravels. Channelized north of Metro Motors from Lougheed Highway to Shaftsbury Pl. Residential yards encroach on both banks, including retaining walls at stream edge. Numerous private footbridges. Reed canarygrass abundant in shallow instream areas within channel above. Little instream cover. Riparian vegetation lacking or mostly non-native species, including Himalayan blackberry, Japanese knotweed, and bamboo. Ivy and yellow lamium abundant and hanging into stream in some areas.</p> <p>Habitat Quality: Spawning – Low; Rearing – Low RFI = 19.7%</p>

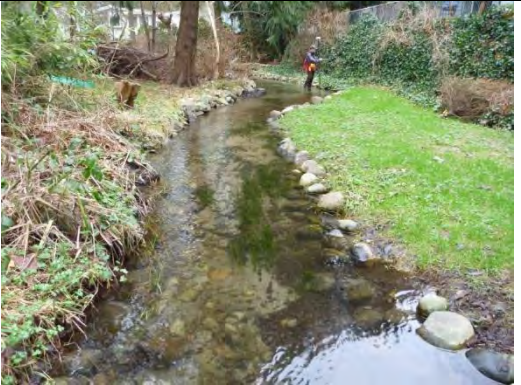
Reach	Stream Class	Description	Photo
Maple R10 3346 Jervis St upstream to Lincoln St	Permanent Fish-bearing	<p>More naturally meandering section but with banks altered by development or lacking riparian vegetation in sections. Residential yards frequently encroach on one or both banks. Abundant cobble/gravel substrates suitable for spawning although covered by fine sediment and somewhat embedded in some areas. Evidence of spawning observed and reported by neighbours. Non-native species common along banks, including ivy, yellow lamium, periwinkle, and cherry-laurel. At least two submerged fences cross stream (partial barriers to fish passage).</p> <p>Habitat Quality: Spawning – Moderate (High?); Rearing – Low RFI = 63.3%</p>

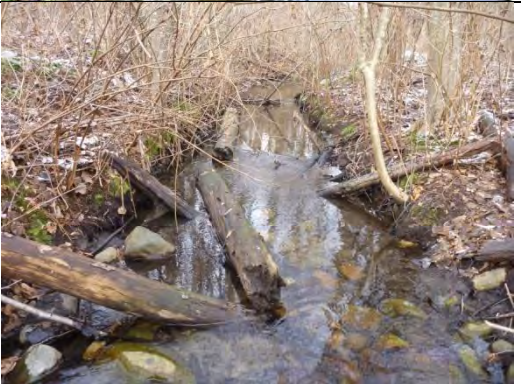
Maple R11 Lincoln St upstream to diversion	Permanent Fish-bearing	<p>Semi-natural, meandering section on perimeter of school grounds. Substrates dominated by fine sediment (some areas of reed canarygrass instream) above Lincoln Ave but with some cobble/gravel sections in upper areas. Fair amount of naturally occurring large woody debris and some undercut banks provide good cover. Wide riparian buffer dominated by native species but ivy, yellow lamium, and Himalayan blackberry choking sections north of playing field adjacent to townhouse complex.</p> <p>Habitat Quality: Spawning – Moderate; Rearing – Moderate RFI = 73.3%</p>

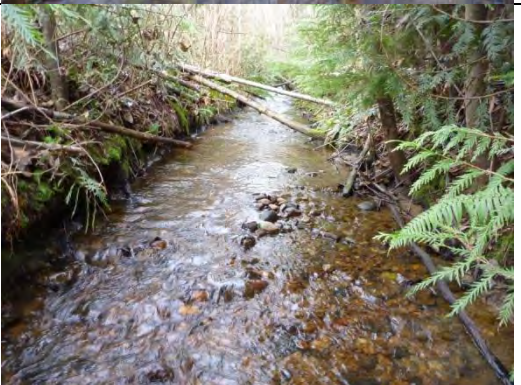
Maple R12 Diversion upstream to Ozada St outfall	Permanent Fish-bearing	<p>Fairly straight section upstream of concrete diversion wall. Substrates dominated by large gravel suitable for spawning, except in upper section which has become filled with sand. Some instream woody debris and undercut banks provide good cover although channel complexity limited by lack of meander in channel. Wide riparian corridor in protected park area, although narrower on right bank due to proximity to Ozada Ave.</p> <p>Habitat Quality: Spawning – Moderate; Rearing – Moderate RFI = 78.6%</p>

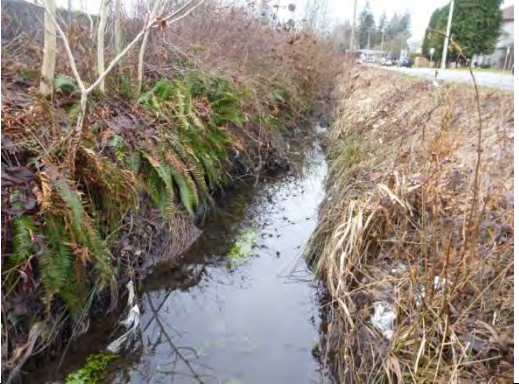
Reach	Stream Class	Description	Photo
Maple Trib. 1 R1 Confluence with Maple Creek upstream to Terasen Gas ROW	Permanent Unknown fish presence	<p>Constructed drainage channel. Deeply incised with steep banks. Substrates mostly mud. Instream wood present providing some cover. Originates from outfall north of Terasen Gas right-of-way. Headwaters appear to have been lost to past development.</p> <p>Habitat Quality: Spawning – Nil; Rearing – Low RFI = 55.4%</p>	 
Fox (Maple Trib. 2) R1 Ditch along Davies Ave	Permanent Fish-bearing	<p>Ditch running along south side of Davies Ave. Substrates dominated by fine sediment. Lack of instream cover but overhanging shrub vegetation provides good cover in some sections. Riparian vegetation is generally confined to right bank in very narrow area. Instream garbage and debris present throughout. Receives runoff directly from roadway.</p> <p>Habitat Quality: Spawning – Low; Rearing – Moderate RFI = 14.0%</p>

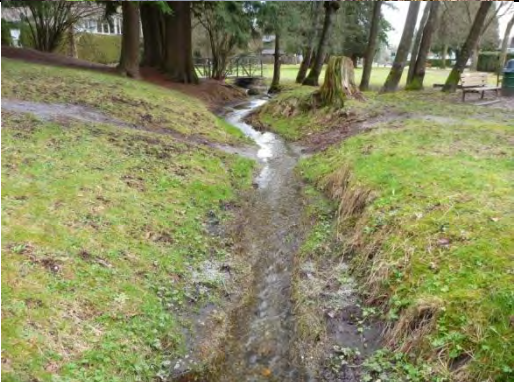
Fox (Maple Trib. 2) R2 Upstream of Davies Ave to Lougheed Highway	Permanent Non fish-bearing	<p>Lower section culverted beneath Fox St and Davies Ave for 120 m. Fox Park section is small channel with no riparian vegetation (few trees) and grass to both banks. Substrates mostly fine gravel and sand. Channel flows through backyards and greenbelt above. Heavy encroachment visible in yards with retaining walls, fence crossings, Instream garbage and debris present throughout greenbelt area.</p> <p>Habitat Quality: Spawning – Nil; Rearing – Low RFI = 33.6%</p>

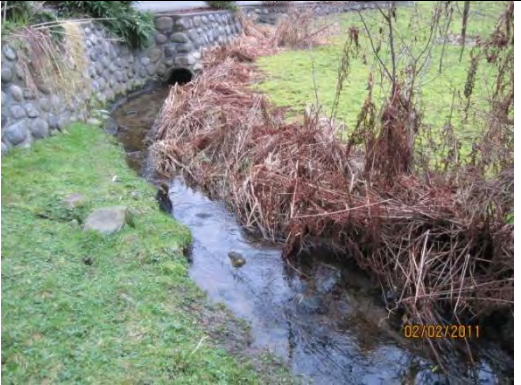
Reach	Stream Class	Description	Photo
Maple Trib. 3 R1 Confluence with Maple Creek upstream to Hastings PI	Permanent Fish-bearing	<p>Small tributary of Maple Creek not mapped in City-provided GIS data. Originates from outfall south of Hastings PI cul-de-sac and joins Maple Creek upstream of Kitchener Ave (total length = 104 m). Substrates dominated by large and small gravels. Upper section runs between lawn and rock wall. Neighbours report seeing juvenile salmonids regularly right up to outfall but spawning not observed. Flows year-round so likely groundwater-fed.</p> <p>Habitat Quality: Spawning – Low; Rearing – Low RFI = 42.2%</p>

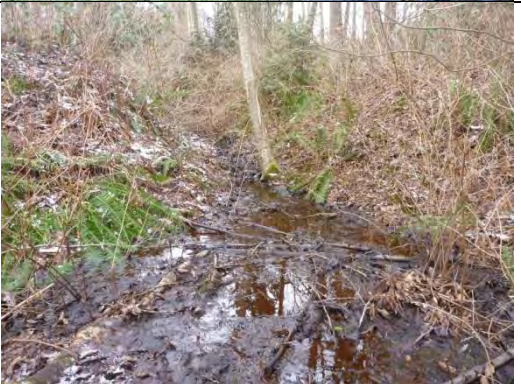
Maple Trib. 4 R1 Confluence with Maple Creek upstream to NW side of playing field	Non-permanent Non fish-bearing	<p>Small tributary wrapping around north side of small, secondary playing field west of school. Substrate mostly leaf litter, mud, and organic debris indicating lack of scouring flows typical of permanent stream. Minimal flow present at time of survey. Does not appear to be groundwater-fed. Enters Maple Creek across a muddy fan. Intact riparian vegetation.</p> <p>Habitat Quality: Spawning – Nil; Rearing – Nil RFI = 64.4%</p>

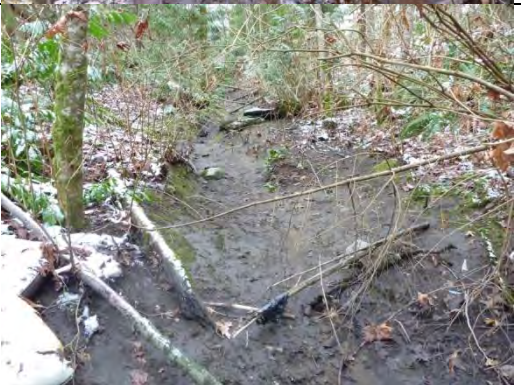
Maple Creek-Coquitlam River Diversion Channel	Non-permanent Unknown fish presence	<p>Constructed, straight channel which carries diverted flow from Maple Creek to Coquitlam River. Substrates dominated by fine sediment with some large boulders. Channel dries out under low flow conditions. Some instream large wood debris but little channel complexity. Wide riparian corridor on either side in protected park area.</p> <p>Habitat Quality: Spawning – Low; Rearing – Low RFI = 100.0%</p>

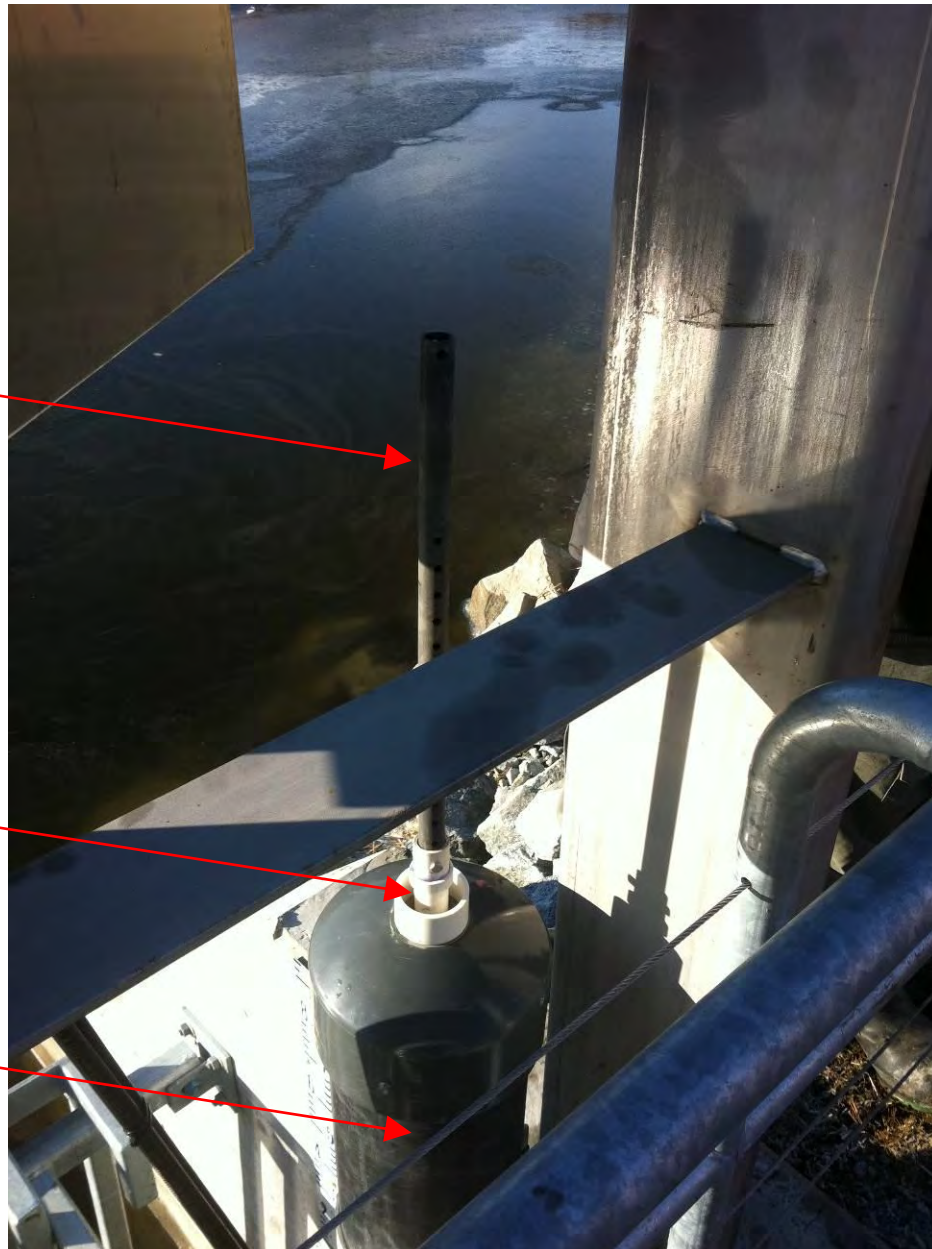
Figure E-5: Float Control Rod (Float Rod and Adjustment Rod)

Float Rod

Stilling Well

Note: Control kiosk has been swung out of the way for clarity but is not required to adjust the trigger water level setting.

1. Unlock and open the control kiosk;
2. Loosen the pipe clamp under the kiosk which holds the bellows protecting the float rod;
3. Unscrew and remove nut/bolt at the top of the adjustment rod (black pipe) to allow the adjustment rod to pass through the hole in the bottom of the kiosk;

7. Replace and tighten the nut/bolt which fastens the adjustment rod and float rod together;
8. Lift the adjustment rod (black pipe) back through the hole in the bottom of the cabinet;

9. Replace and tighten the bolt/nut at the top of the float control rod (black pipe);
10. Make sure that the rod is moving freely through the hole in the cabinet;

It should be noted that fine adjustments to the trigger water level can be made by adjusting the pad on the end of the poppet trigger lever inside the control kiosk.

1. Unlock and open the control kiosk;
2. Loosen the pipe clamp under the kiosk which holds the bellows protecting the float rod and lower the bellows;
3. Unscrew and remove nut/bolt at the top of the adjustment rod (black pipe) to allow the adjustment rod to pass through the hole in the bottom of the kiosk;
4. Unlock and remove the pin supporting the control kiosk on right hand side;
5. Confirm that the adjustment rod is clear of the bottom of the kiosk and swing the kiosk outwards;
6. Remove cap from the top of the stilling well by unscrewing three screws holding the cap in-place; and
7. Remove the float by lifting on the float control rod.

When putting the float rod back into place be certain that the adjustment rod is inserted back into the hole in the bottom of the kiosk and the nut/bolt is replaced in the top of the adjustment rod to hold it in place.

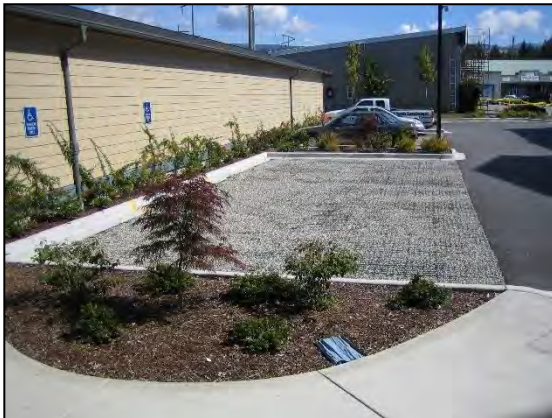
Reinforced Clean Crushed Gravel

Use of pervious paving materials rather than impervious concrete or asphalt can reduce the runoff generated from parking areas. Pervious materials may include pavers, reinforced clean crushed gravel, reinforced turf, or engineered permeable pavements.

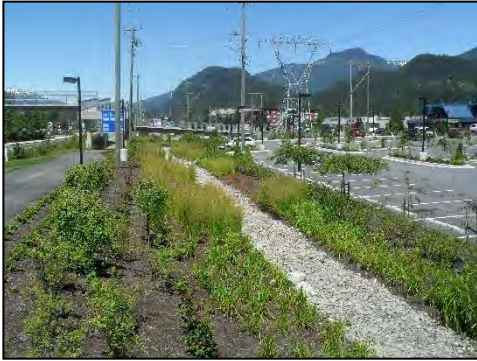
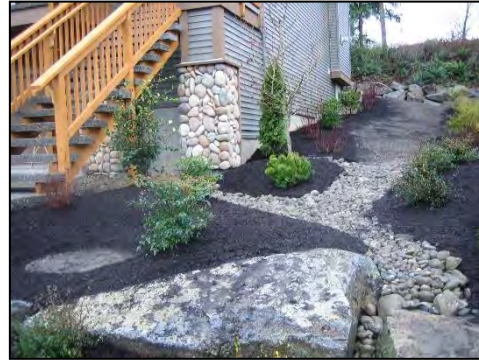
Absorbent Landscaping

Some maintenance over the long term is required for the absorbent landscape to continue to provide stormwater benefits. Maintenance activities may include replacing soils that have eroded and replanting dead or dying vegetation.

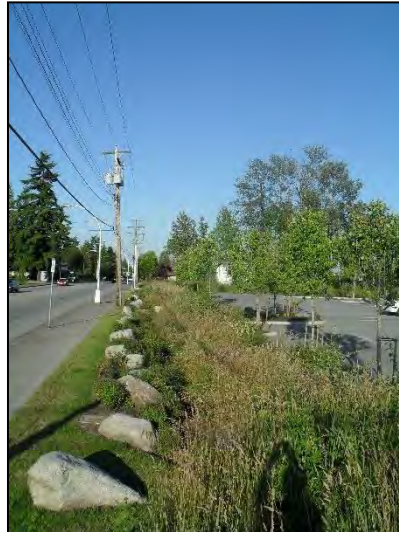
Bio-Retention Swale

Where applicable, a retention facility may also be designed as a baseflow augmentation facility that retains the design capture volume in a tank or pond and releases it at baseflow rates. These rates are very low and are based on measured summer baseflows in a watercourse divided by the contributing watershed area, and then applied to the area of the site contributing runoff. Baseflow augmentation facilities discharge the capture volume to the downstream stormwater system or watercourse at a maximum of the determined baseflow rates. Any volumes above the capture volume must be allowed to bypass the baseflow augmentation facility.

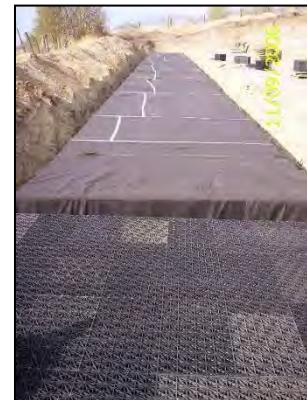
Sub-Surface Infiltration

Sub-surface facilities must be located at least 0.5 m above the level of the water table so that they can discharge through the sides and bottom of the structure and will not merely store infiltrated groundwater. Generally, the deeper an infiltration facility is located, the less-effective it will be. Subsurface infiltration facilities can be as simple as a trench filled with clean, free-draining rock that is protected from soil by a permeable membrane. There are numerous products available commercially for subsurface infiltration as well.

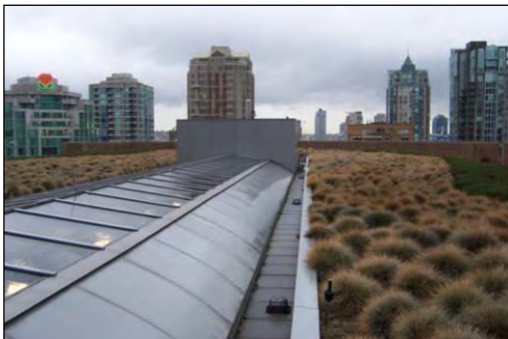
Green Roof

Green roofs are more expensive to build as they have structural costs as well as landscaping costs and do require maintenance to ensure their ongoing functionality. However, when compared with land costs for alternate facilities in high density urban areas, the costs for a green roof may be favourable. Green

roofs also have other benefits, in addition to stormwater benefits, that can include heating or cooling cost savings by insulating the building, aesthetic benefits, air quality benefits, and reduced solar gain that decreases the urban heat island effect. Green roofs should only be designed and constructed by qualified professionals as structural engineering, building envelope and landscape design as well as stormwater engineering are all critical components. Green roofs are the preferable source control in areas where ground surface controls are not possible. For more information on green roofs readers are referred to the [Green Roofs for Healthy Cities](#) website.

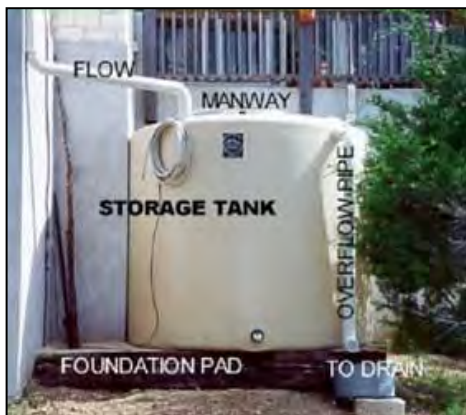
Re-Use Tank

Rainwater re-use is commonly afforded by residential rain barrels which are effectively retention facilities for roof runoff. Limitations of rain barrels are that rainfall is seldom a reliable source for water during the dryer seasons and rain barrels are often not large enough to store the 50% of 2-year capture target. The most significant reductions in runoff volume from re-use are achieved by capturing and re-using rainwater for indoor grey-water uses, or for commercial and industrial applications with high water consumption rates or where water supplies are limited. Recycling rainwater reduces demands from surface waters and reservoirs and can reduce supply infrastructure costs. Rainwater re-use can also be combined with infiltration facilities.

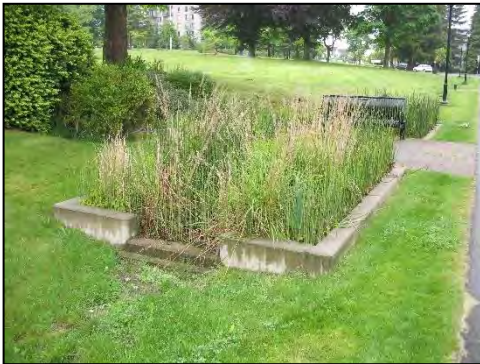
Small Wetland

Physical, biological and chemical processes combine in wetlands to remove contaminants and either surface or subsurface flow wetlands can be constructed specifically to treat stormwater runoff. Constructed wetlands also offer retention benefits and can create preferred habitats for aquatic and terrestrial wildlife species. **The use of existing natural wetlands to treat stormwater however is not an acceptable practice.**

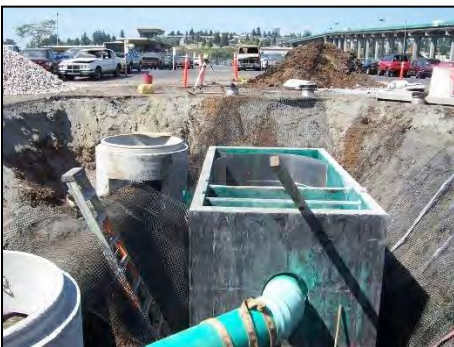
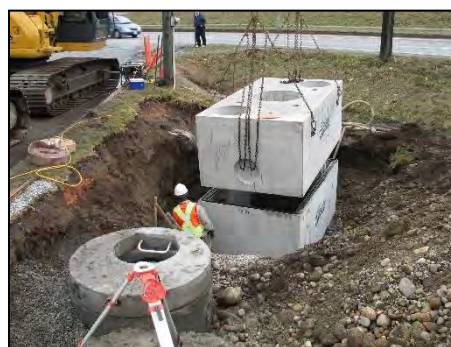
Oil Grit Separator

Oil and grit separators are suitable for spill control and removal of floatable petroleum-based contaminants as well as coarse grit and sediment from small areas, such as gas stations, automotive service areas and parking lots. Oil and grit separators have limited application in large-scale stormwater runoff applications and should be limited to small area generation sites.

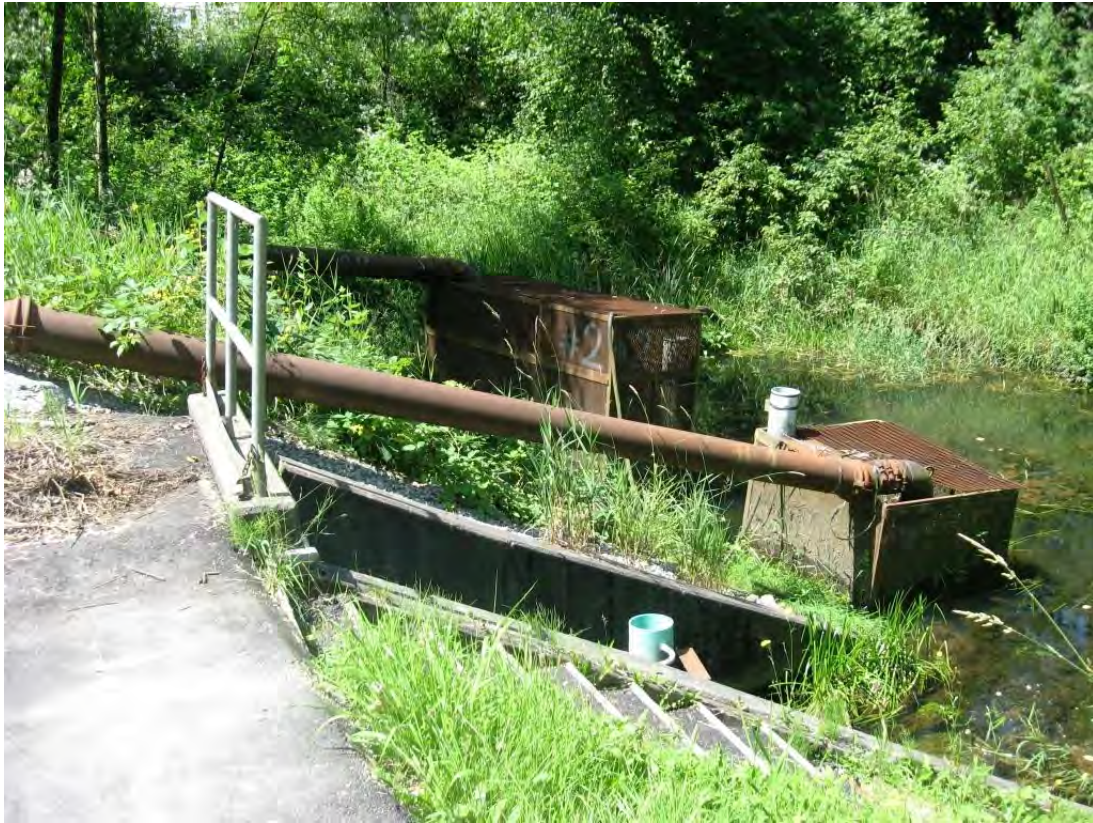
Photo 2-1: Existing Pump Arrangement

- **Power Supply:** A BC Hydro pole is located west of the existing flood box structure and supplies power to the wooden control box via a 600V to 460V step down pole mount transformer.

- **Power and Control Box:** Unable to access for observation.

2.2 Existing Pump Station (Photo 2-1)

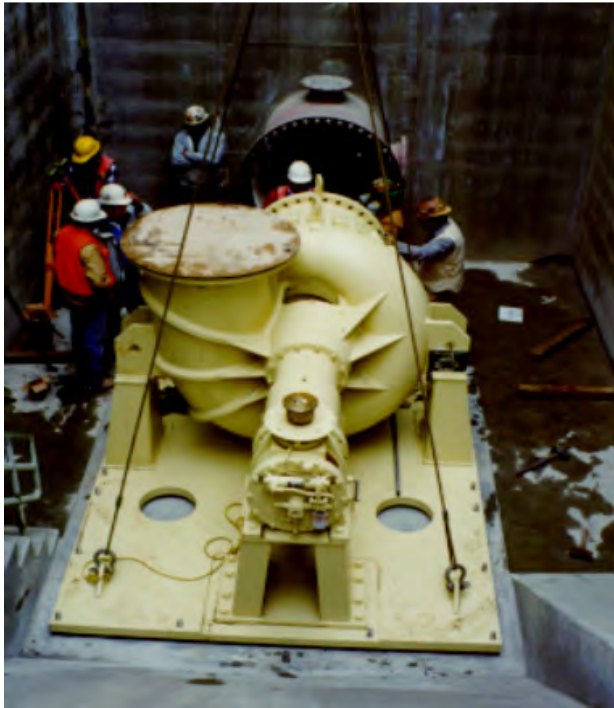
Photo 3-1: Dry Pit Hidrostral Pump (Red Bluff, California)

Hidrostral is manufacturer of “fish friendly” pumps. The pumps are designed with an impeller that has a conical shape capable of passing large solids or in this case, fish. Hydrostral pumps have been used in number of fish applications including Wilson Farm in Port Coquitlam (currently under construction), Maple Pump Station in Surrey (under Construction) and the Red Bluff Pump Station in California.

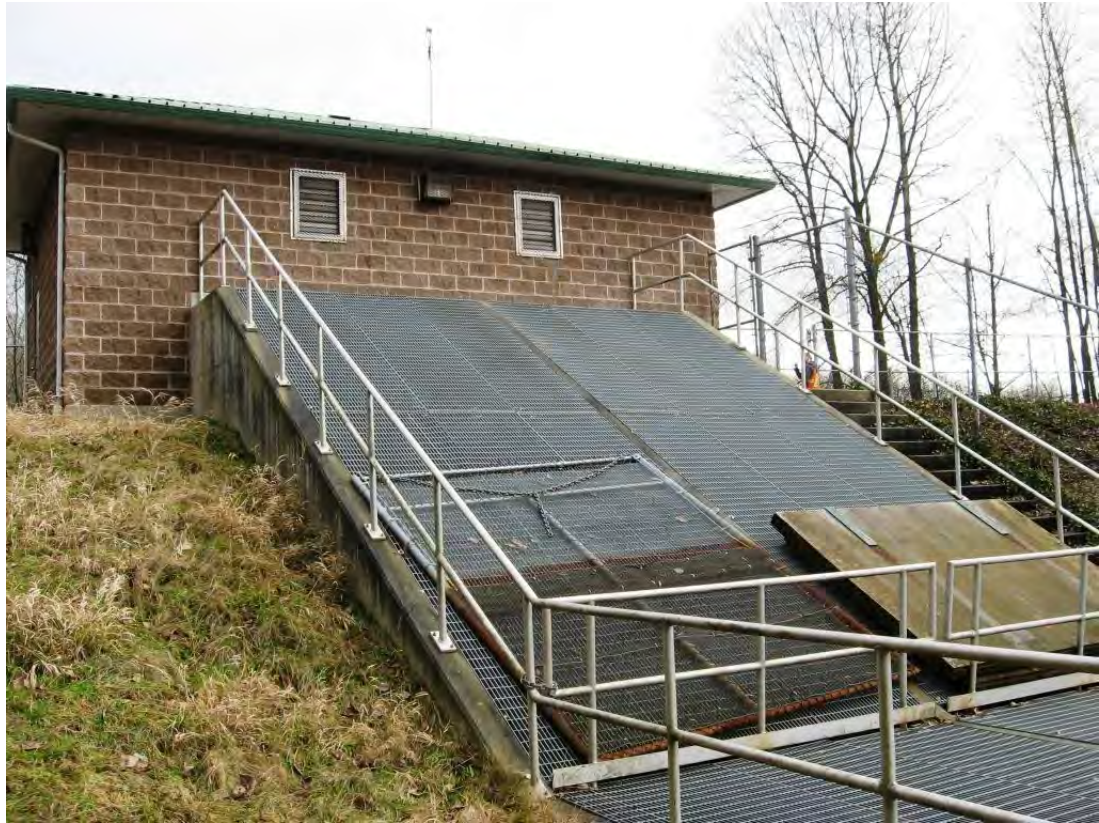
Photo 3-2: Typical Screw Pump Installation

Re-grading of the existing dyke will be required to facilitate the culvert construction. Raising the level of the dyke locally around the proposed station will not impact the adjacent housing.

The estimated cost of the proposed screw pump station is \$ 3.5 M. A breakdown of the estimate is attached to this report.

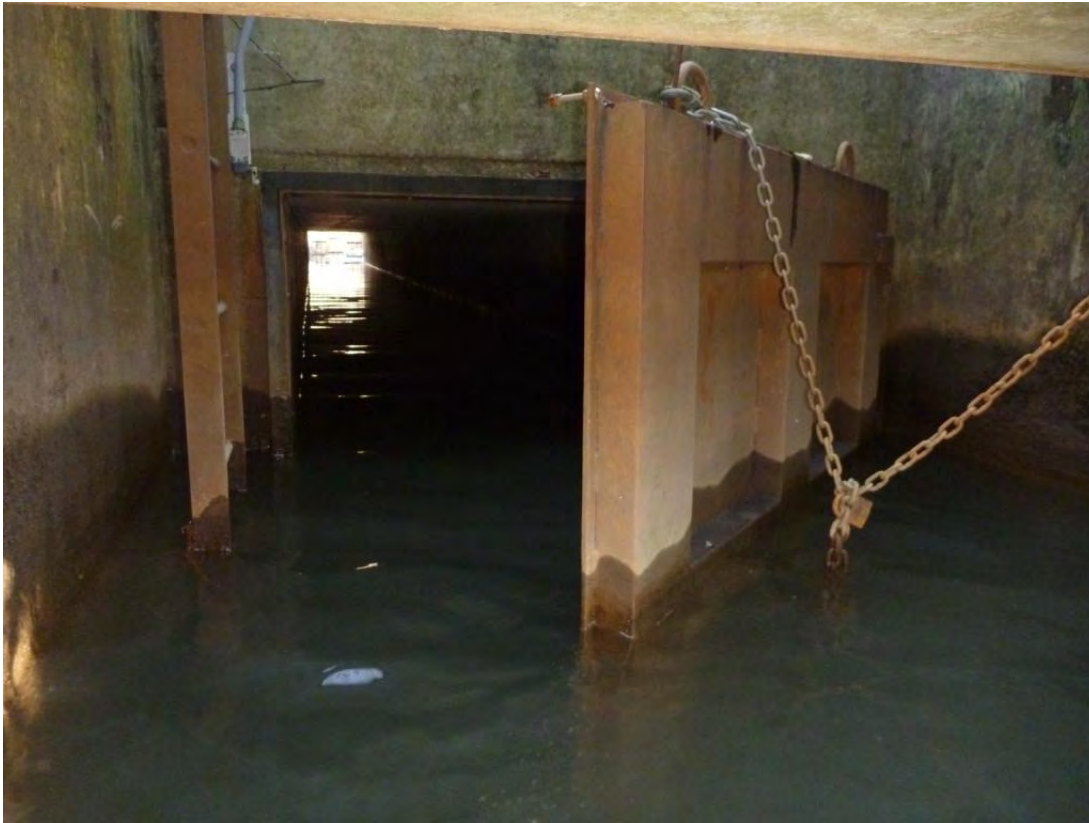
As mentioned on page 2-17 of the Watershed Management Report, the flapgate has been previously identified as an impediment to fish passage because of the low frequency with which the gate remains open to fish passage. A weight was retrofitted to the gate to allow it to open during low flow periods and reduces the size of flows required to open the gate. In spite of these changes there have been reports of the gate being observed closed on sunny, low flow days resulting in the pumps operating to pump the base flow.

Photo 4-1: Existing Flapgate (with weight attached)

The proposed gate system will have a control mechanism that asserts an adjustable amount of bias (in the form of a moment/torque) causing the gate to open. The bias can be zero, in which case the flap gate will operate as it does now. A small amount of bias will cause the flap gate to be partially open when there is no seating head. Increasing the bias will cause the gate to be more wide-open when the water levels are equal upstream and downstream from the gate.

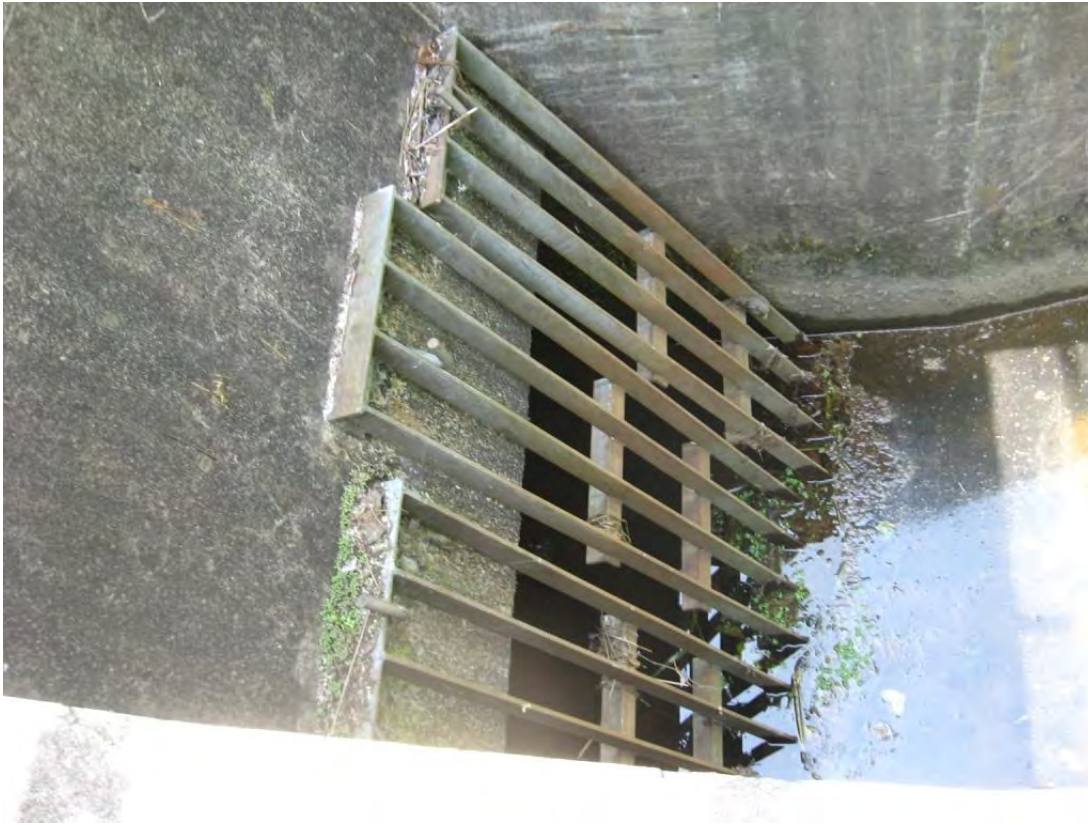
Photo 4-2: Inlet Grille

The grille on the upstream side of the flood box is designed to prevent garbage and debris from entering the flood box and possibly plugging the flood box structure which may result in flooding upstream of the dyke. Stream keepers have identified the grille as an impediment to fish passage. Some bars have been removed to enhance fish passage.

Removal of the inlet grille will allow fish to pass freely through the flood box. If debris build-up remains a concern, a more appropriately sized grille could be installed to reduce the impediment to fish passage.

- Coquitlam River dyke floodbox grill (upstream end) (Photo 2-1b): The grill on the upstream end of the floodbox is to capture garbage and debris. It has previously been identified as an impediment to fish passage (Thomson, 1997). The grill was modified slightly to improve fish passage (one bar removed). However, the grill can still become clogged and block fish passage if it is not regularly cleaned. Streamkeepers have suggested that the grill is not necessary and could be removed.
